Effectiveness of Straw Bale Dams for Erosion Control in the Oakland Hills Following the Fire of 1991

Laurel M. Collins¹ and Christopher E. Johnston²

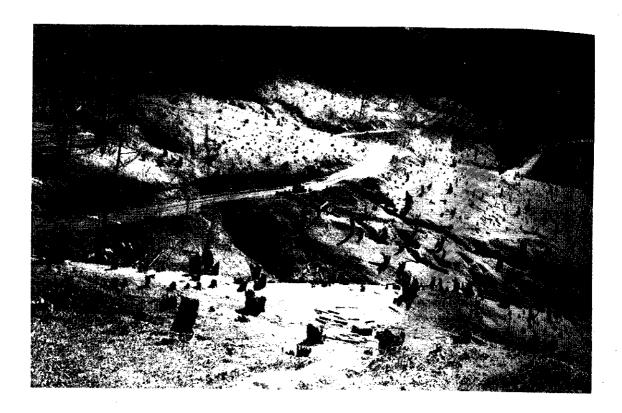
Figure 3. Central portion of the NOSC site. Note erosion associated with the dirt road, which was not protected with erosion control measures, even though most of the watershed was aerial seeded, seeded with hydromulch (mixed with soil sealand) and straw bales were added to all the guillies and landslides.

most of the eucalyptus trees were cut (but not killed) about two years prior to the fire (Fig. 3). The NOSC site has a broad flat valley that was created by fill from the excavation of Caldecott Tunnel. At the upper end of the valley fill, at the apex where upland gullies are intersected, a new alluvial fan has developed over the last few decades. Six rows of straw bale barriers (n = 112 bales) were placed on the fan to enhance natural sediment deposition, limit its spread onto the sports green at the lower end of the valley fill, and reduce downstream sedimentation to Lake Temescal.

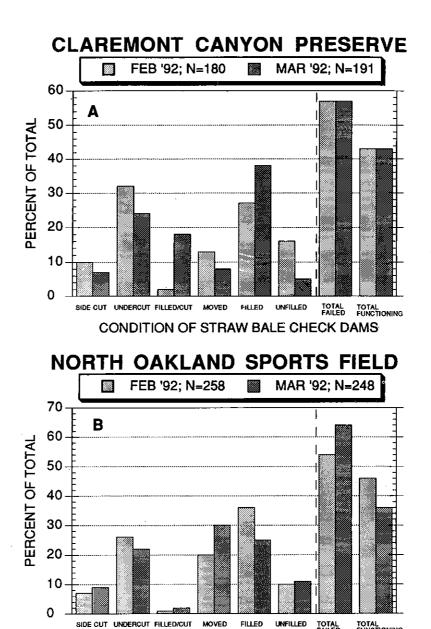
The results of the check dam analysis are shown in Figure 5a and b. By the third month after the bales were installed only 43% of the straw bale dams in CCRP and 46% in the NOSC were functioning to reduce the

erosion potential. About 60% (330 mm) of the total rainfall (since the bale installation) had already occurred. After 4.5 months (end of March) a respective 43% and 37% were functioning. The reason the number of functioning dams In CCRP did not change may have been due to the plugging of holes and repairing of dams by labor crews after the February storms. Repairs on other straw bale dams within gullies were not consistently observed In NOSC. Crews from the California Conservation Corps (CCC) inspected some of the bales in the gullies of NOSC in early February (David

Figure 5a and b. Percentage of functioning and non-functioning straw bale check dams in the watersheds.
