**Geomorphic Characterization of Historical Reservoirs,
Stock Ponds and Wetland Landscapes
Supporting Red-legged Frogs
in the
Phillip Burton Wilderness, Point Reyes National Seashore**

FINAL REPORT FOR THE POINT REYES NATIONAL SEASHORE

Laurel Collins and Joshua N. Collins, Ph.D.

March, 2007

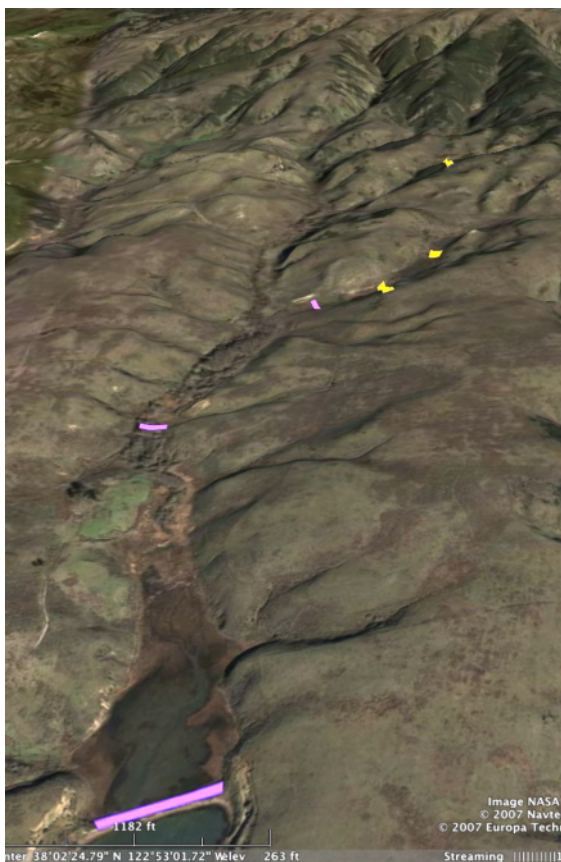
Figure 4: Glenbrook watershed showing mainstem and major tributary dams (pink dams are breached). The lowermost mainstem dam was breached in the historic January 1982 storm.

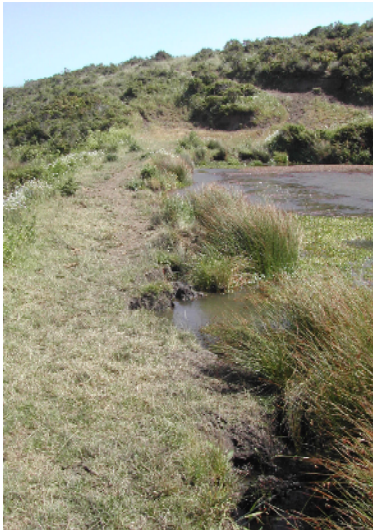
P-071: Wave erosion along interior dam face.

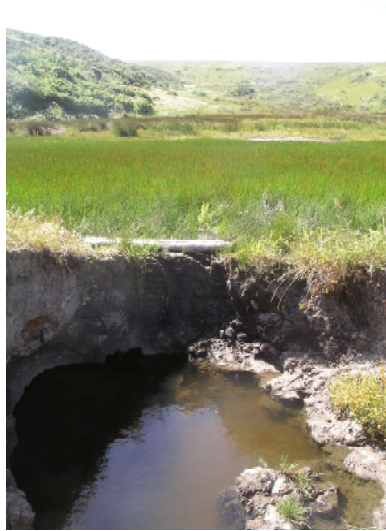
P-070: Headcut up spillway into exterior dam face.

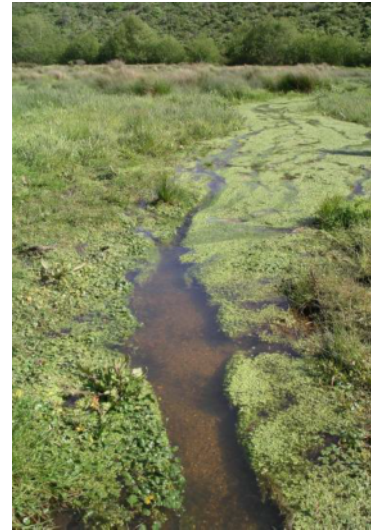
P-066: Avulsion of Home Ranch Creek forming new wetlands.

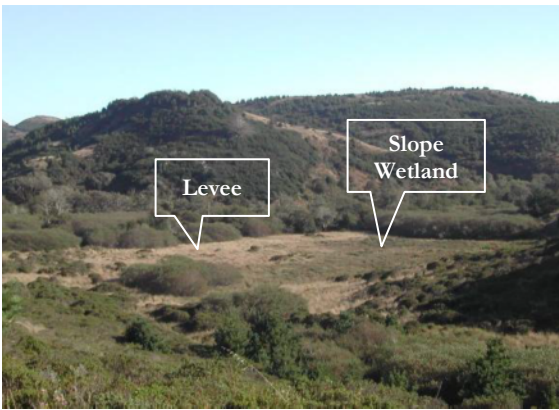
P-058c: Slope wetland forming behind natural levee along Muddy Hollow Creek..

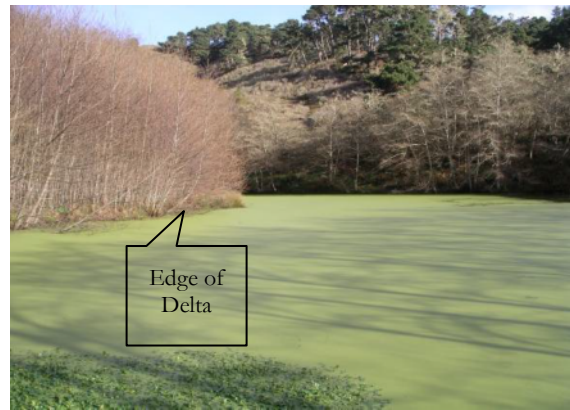
P-054: Alders on delta forming from in-fill at upstream end of impoundment.

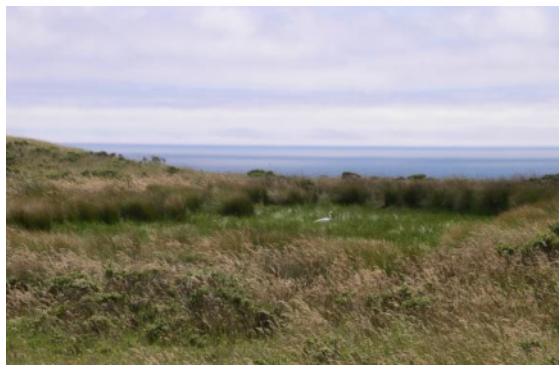
PC-11: Natural seasonal wetland in topographic depression on ridge top. Also see Figure 18.

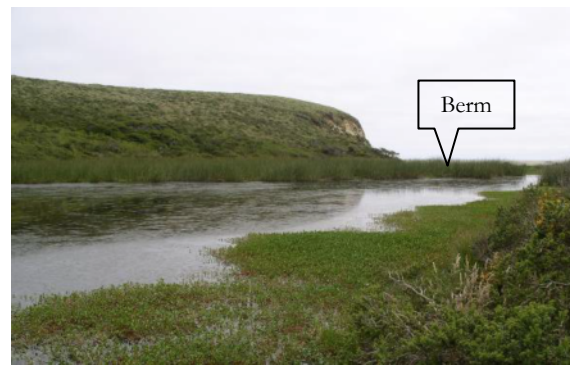
P-187: Coastal lagoon behind berm built of sand and debris deposited by wind and waves along estero shoreline.
