Runoff and Erosion after the Oakland Firestorm

Expectations and Observations

F.A. Booker, W.E. Dietrich, and L.M. Collins
University of California, Berkeley

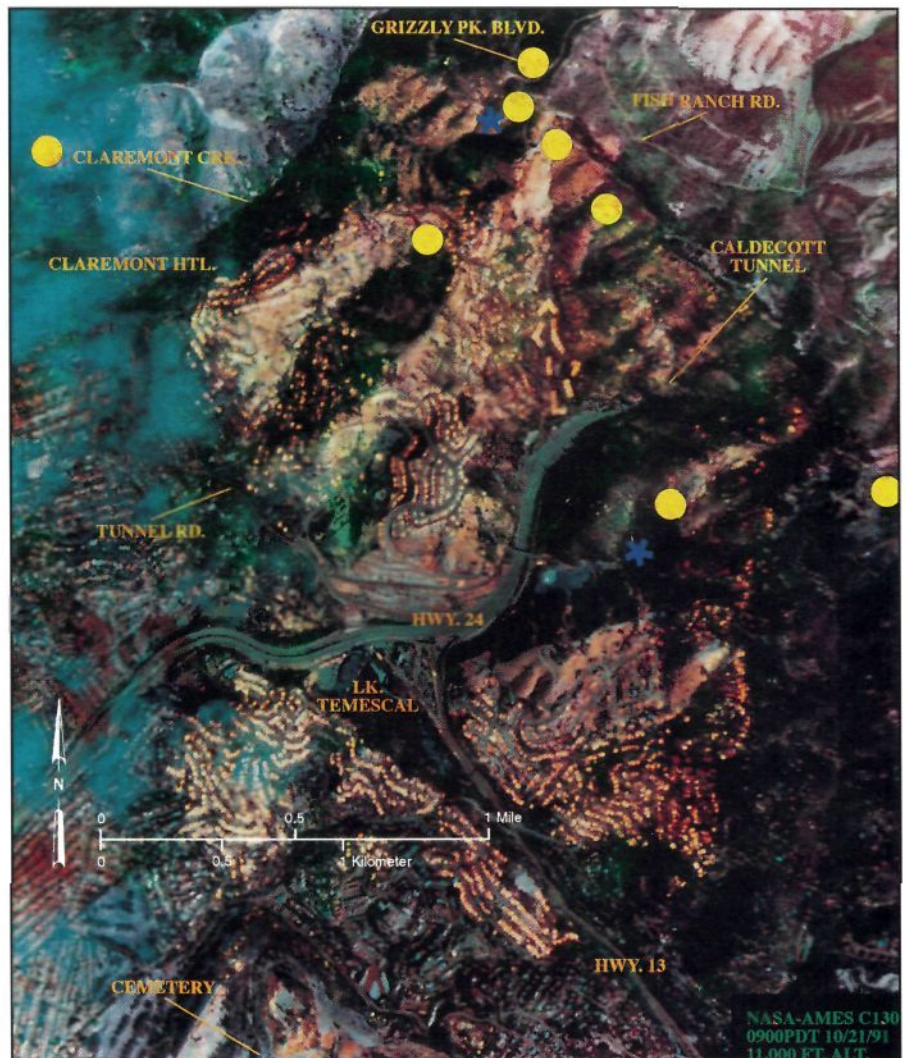
Photo 1. NASA-Ames air photo of the Oakland Firestorm area. Bright lights are burning foundations. The fire is bounded by Tunnel Road on the west, Claremont Creek on the north, and Grizzly Peak Boulevard on the east. The southern boundary is delineated by burning homes. Yellow dots designate runoff and erosion plot sites. Claremont Creek Regional Park and North Oakland Sports Center straw bale sites are marked by blue "stars."

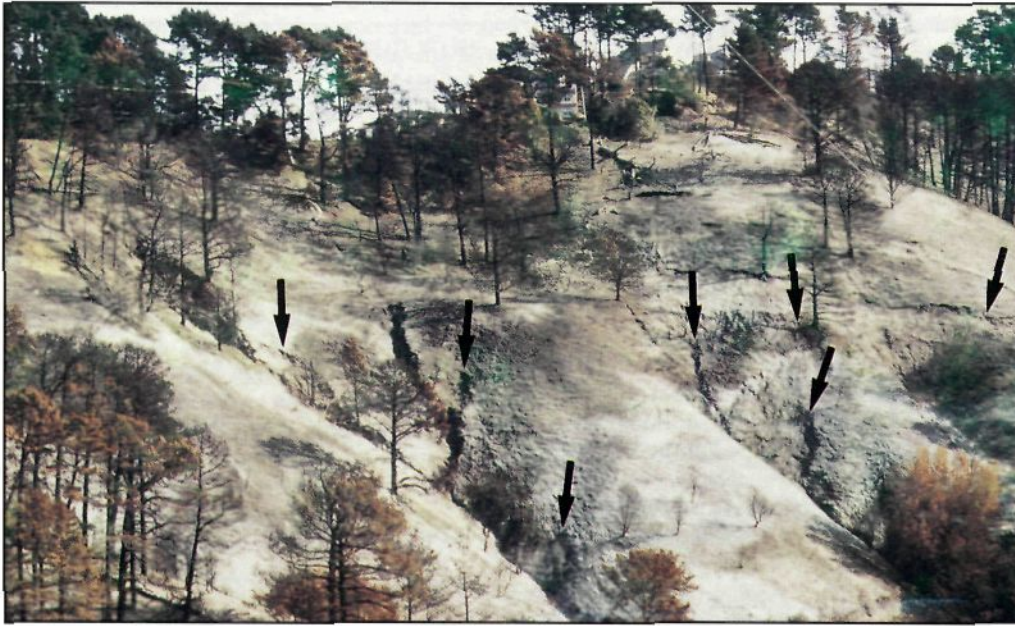
Photo 2. Old landslide and debris flow scars shown by arrows (some associated with road runoff) are revealed following the loss of vegetative cover in the Oakland Hills fire. These slopes have been treated with a hydromulch application of seed, mulched paper, wood fiber, and acrylic copolymer glue.

After the fire, the vegetation-free landscape offered a clear view of the numerous landslide scars that had formed during previous years (Photo 2). These landslides, mostly slides, slumps, and flows, contrast with the "fire-flood" debris flows that are generated in steep canyon bottoms in freshly deposited ravel. Most are relatively shallow slope failures that occur following increases in ground saturation. Shallow soil slides can develop into fast moving debris flows of saturated soil, whereas slumps and earth flows are typically slow moving. Debris flows are initiated during intense rainstorms under specific conditions of antecedent ground saturation, rainfall intensity, and storm duration (Cannon and Ellen, 1988). The landslides related to urbanization are commonly shallow slides along road cuts and fills, along gully walls that have been incised by concentrated road runoff, or where the gully incision has destabilized the slope above it.

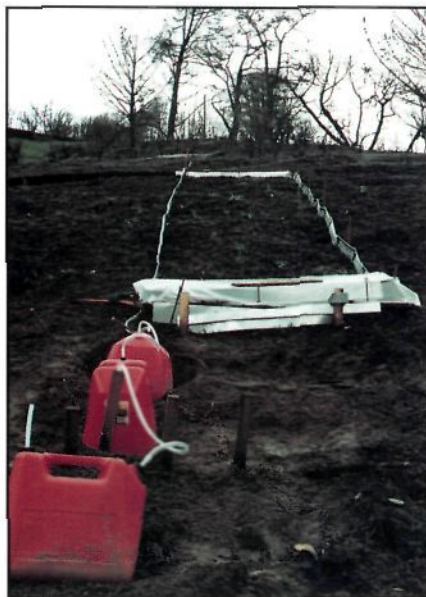
Photo 3. A runoff and erosion plot. Runoff is funneled from the trough to 5-gallon plastic containers connected in series to store runoff and suspended sediment. The emergent vegetation is Indian Soap Plant (*Chloragalum pomeridianum*) and is not a result of the reseeding effort.

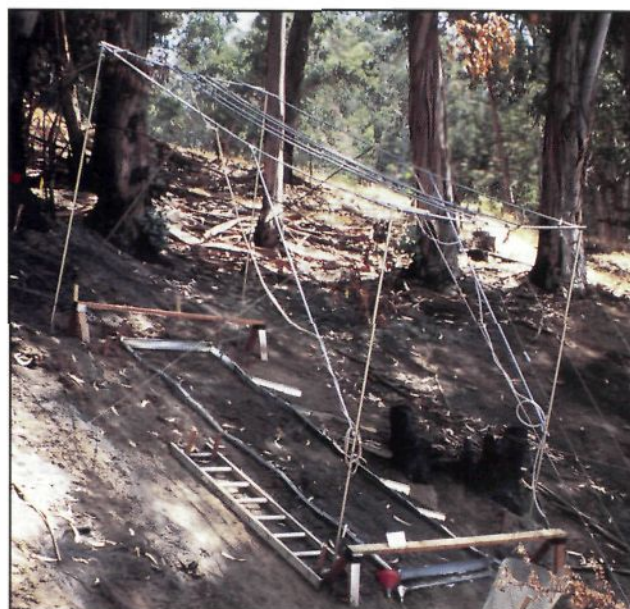
Photo 4. The simulated greater-than-100-year storm was applied by rapidly moving two nozzles on trolleys suspended from central rails in the tubular frame 10 feet (3 m) above the plot. Runoff and sediment were collected from two troughs, an upper trough to monitor overland flow, and a lower trough to monitor flow through the wettable soil layer.

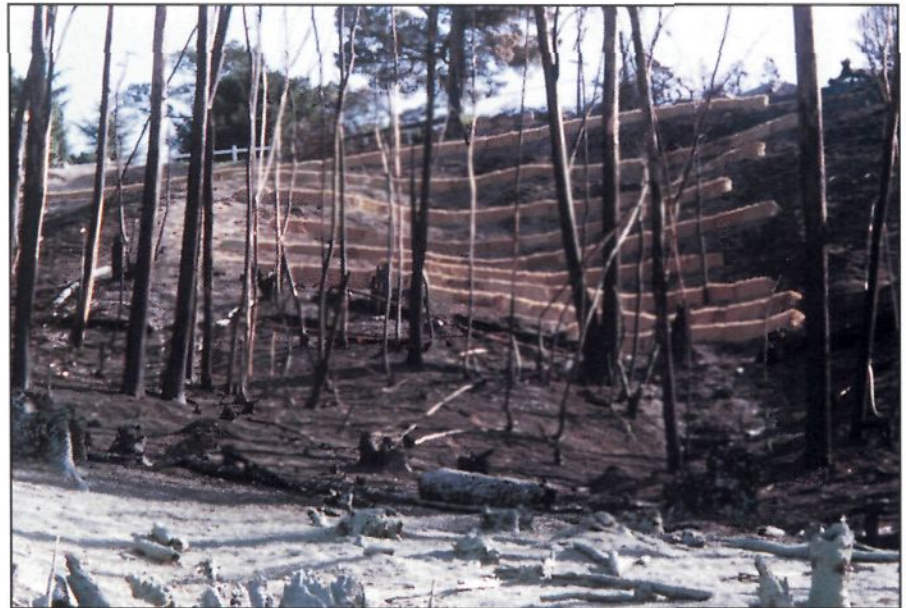
Photo 6. Straw bale check dams or dikes are paced in rows on an old landslide feature. In the foreground the hillside has been treated with the seed and hydromulch application which was eventually sprayed over the entire area.

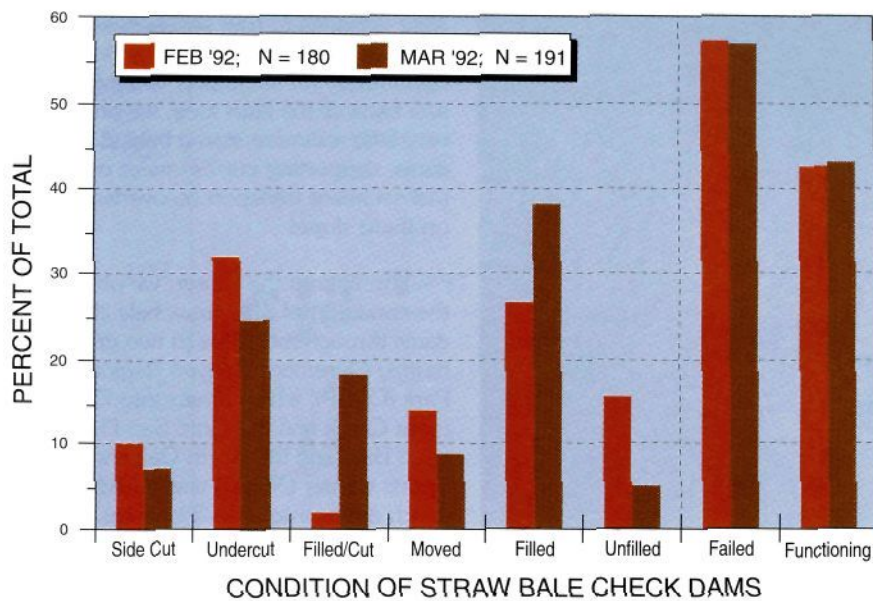
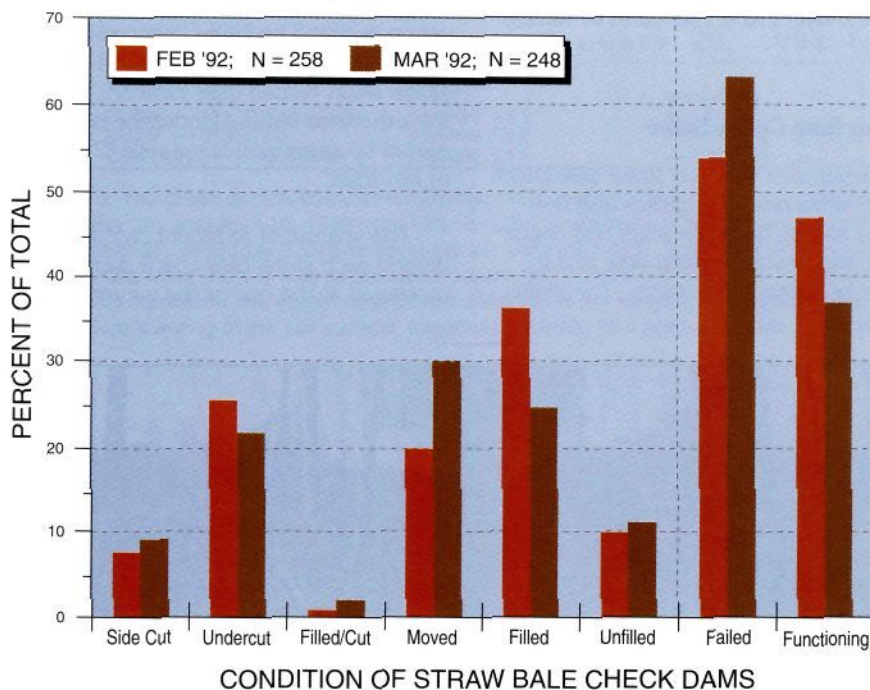
Figures 4a and 4b. Percentage of functioning and non-functioning straw bale check dams in two watersheds.

The dams were evaluated once during February 1992 and again at the end of March 1992. Their condition was rated as: 1) sidecut (water flowed around the dam thereby minimizing sediment storage); 2) undercut (water flowed beneath the dam thereby minimizing sediment storage); 3) filled but cut (dam may have partially or totally filled with sediment

The results of the straw bale analysis are shown in Figures 4a and 4b. If filled and unfilled dams are combined as "functioning properly," then by late February only 43 percent of the CCRP dams and 46 percent of the NOSC dams were moderating sediment transport. By the end of March only 43 percent and 37 percent, respectively, were functioning. At the CCRP site, labor crews repaired most of the dams after February storms, which most likely accounts for the consistent number of functioning bales at this site. In the NOSC watershed, no maintenance was performed on check dams within the upland gullies. However, several straw bale dams were replaced or repaired on an alluvial fan at the base of the upland watershed. Because the broad flat fan is a natural deposition zone, it was one of the few sites where sediment could be quantified in subsequent winters.

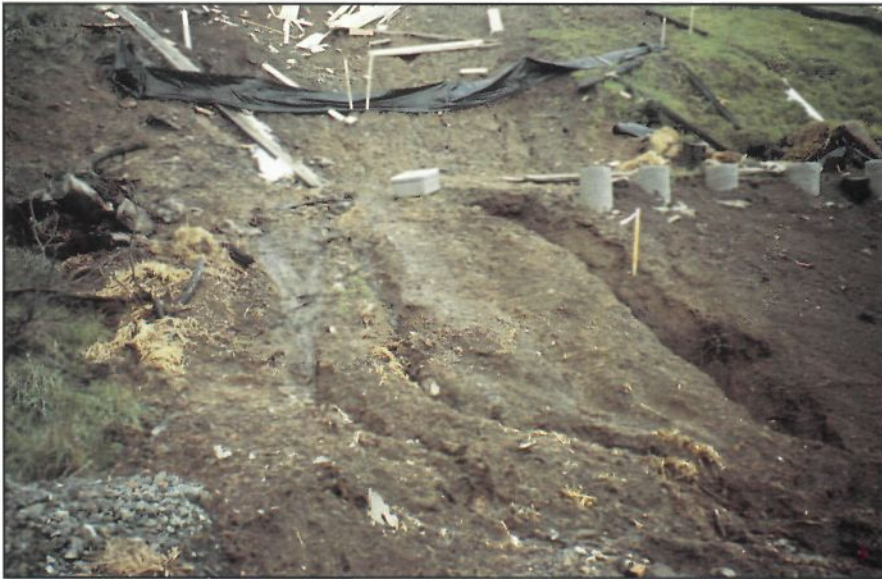
Photo 7. Construction initiated rilling and gulying. There was no erosion control at this site in the burn area.

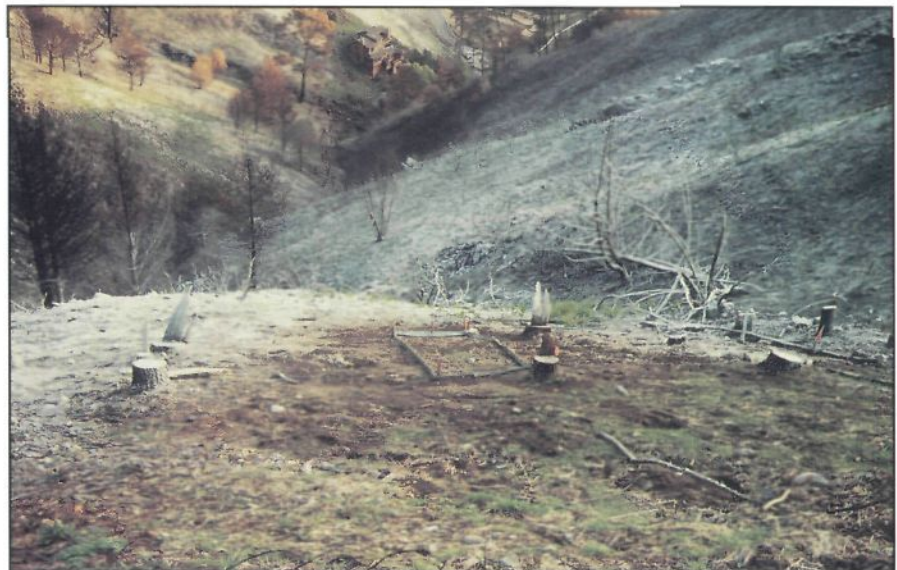
Photo 8. Contrasting grass germination success is seen in this photo taken in early March 1992. Grasses are coming up in the foreground, which has not been hydromulched. In the background, the predominant plants emerging on these treated slopes are local bracken ferns, not grass from the seeding effort.

reduce overall establishment of vegetation. The germination of seeds in these hydromulched areas did not occur until after heavy rains in March, 1992, when the winter was essentially over (Photo 8).

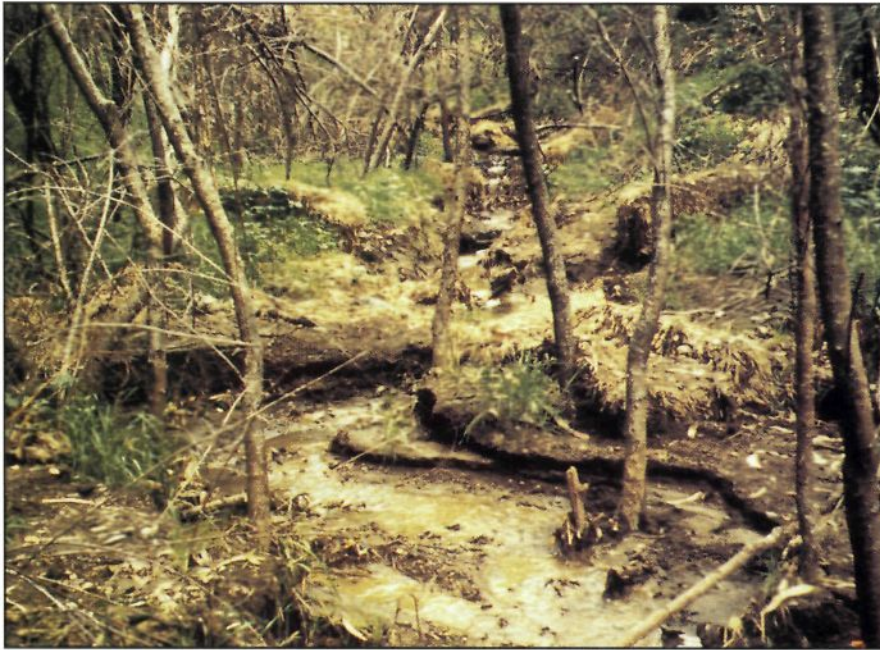
Photo 9. In March 1992, after an average rainfall season, 63 percent of all straw bale check dams in the North Oakland Sports Center watershed had failed.

Standard erosion control manuals state explicitly that straw bale check dams should not be placed in areas that receive more than 1 cubic foot per second (1.7 m³/minute) flow; that the dams have a useful life of about 3 months; and that if they fail there is frequently more damage than if no barrier had been installed (Goldman and others, 1986). These assertions were reconfirmed in the Oakland fire area. The straw bale check dam data suggests that sediment storage is less than 50 percent effective for average winter rainfall conditions, and much less effective for the extreme rainfall event for which planners were preparing (Photo 9). Additionally, much of the sediment caught behind the dams may have come from keying or benching the bales into gully walls. Because many gullies are at least 10 feet (3 m) deep, the sediment that was excavated to install the bales was not removed from the active channel. Sediment was thereby provided to the next downstream dam.
