Stream Network and Landscape Change in the Rodeo Creek Watershed

Report for the Muir Heritage Land Trust

February 2008

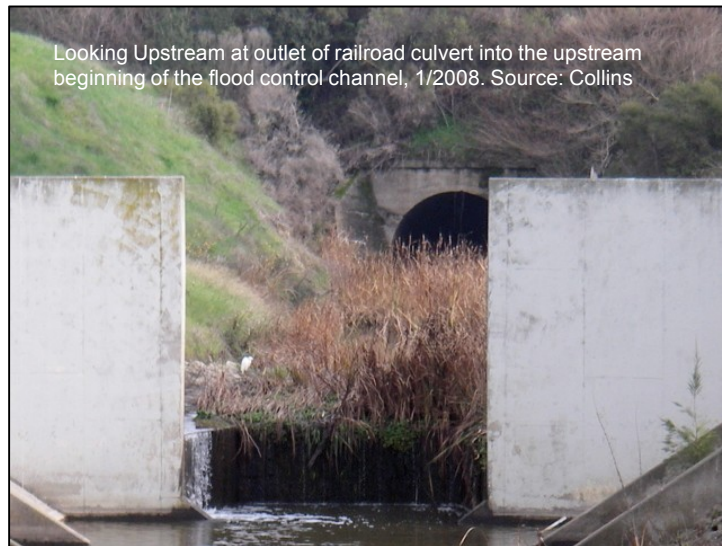
Looking Upstream at outlet of railroad culvert into the upstream beginning of the flood control channel, 1/2008. Source: Collins

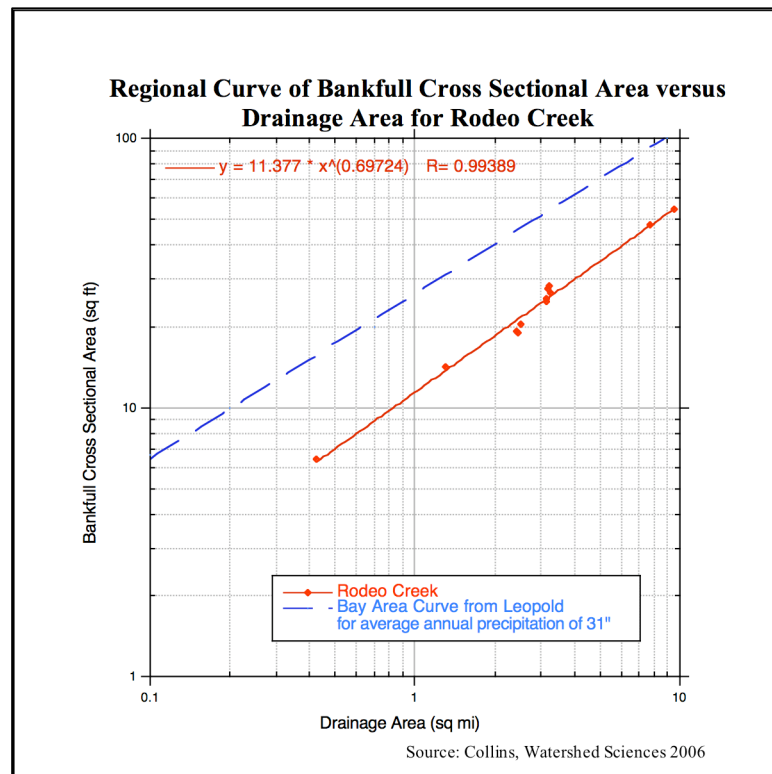
A regional curve of estimated bankfull cross sectional area is shown above to compare values derived by Dunne and Leopold's curve for the general Bay Area to values derived from various cross sections surveyed specifically along Rodeo Creek (Collins 2006). For a 10 square mile drainage area the Bay Area curve predicts a bankfull cross sectional area of about 105 square feet while the locally derived curve predicts a much smaller cross section, approximately 60 square feet. These variations are likely due to differences in average rainfall. The San Francisco Bay Area Curve is derived from various streams that have a combined average rainfall of 31 inches, while average rainfall in the Rodeo watershed is only 21 inches.

Rodeo Creek is perennial through its flood control channel at Rodeo. Bankfull discharge of about 430 cfs has been estimated from a Regional Curve for the San Francisco Bay Area (Dunne and Leopold, 1978) and mean daily flow is 7 cfs (CCCCDP 2003). Although the Army Corps ultimately determined that the design storm for the flood control channel would need to accommodate 3000 cfs, they reduced the design capacity discharge to 2500 cfs because the Burlington Northern/Santa Fe RR culvert upstream of the project area could not convey discharges greater than 2500 cfs (USACE 1962). Different flood recurrence intervals have been determined by others and are listed in the Watershed and Rodeo Creek Statistics Table on page 9.

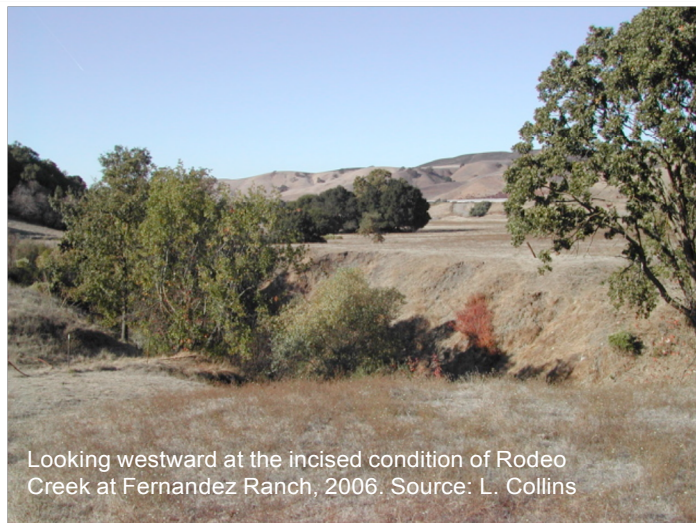
Looking westward at the incised condition of Rodeo Creek at Fernandez Ranch, 2006. Source: L. Collins

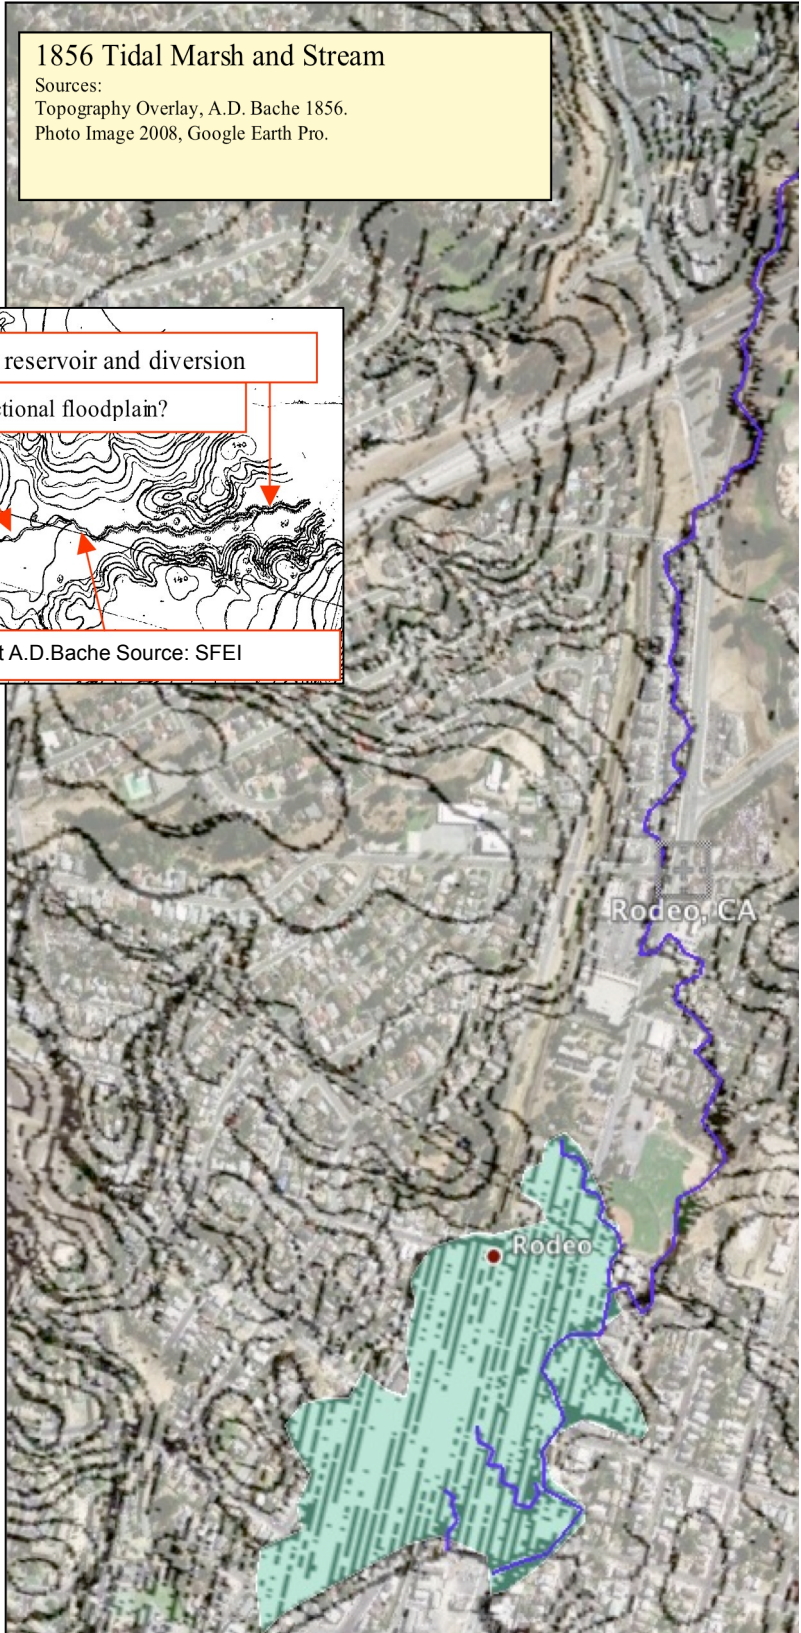
1856 Tidal Marsh and Stream
Sources:
Topography Overlay, A.D. Bache 1856.
Photo Image 2008, Google Earth Pro.

The overlay map to the right shows that much of the Rodeo was situated on a former tidal marsh. The creek flowed along the southern valley edge.

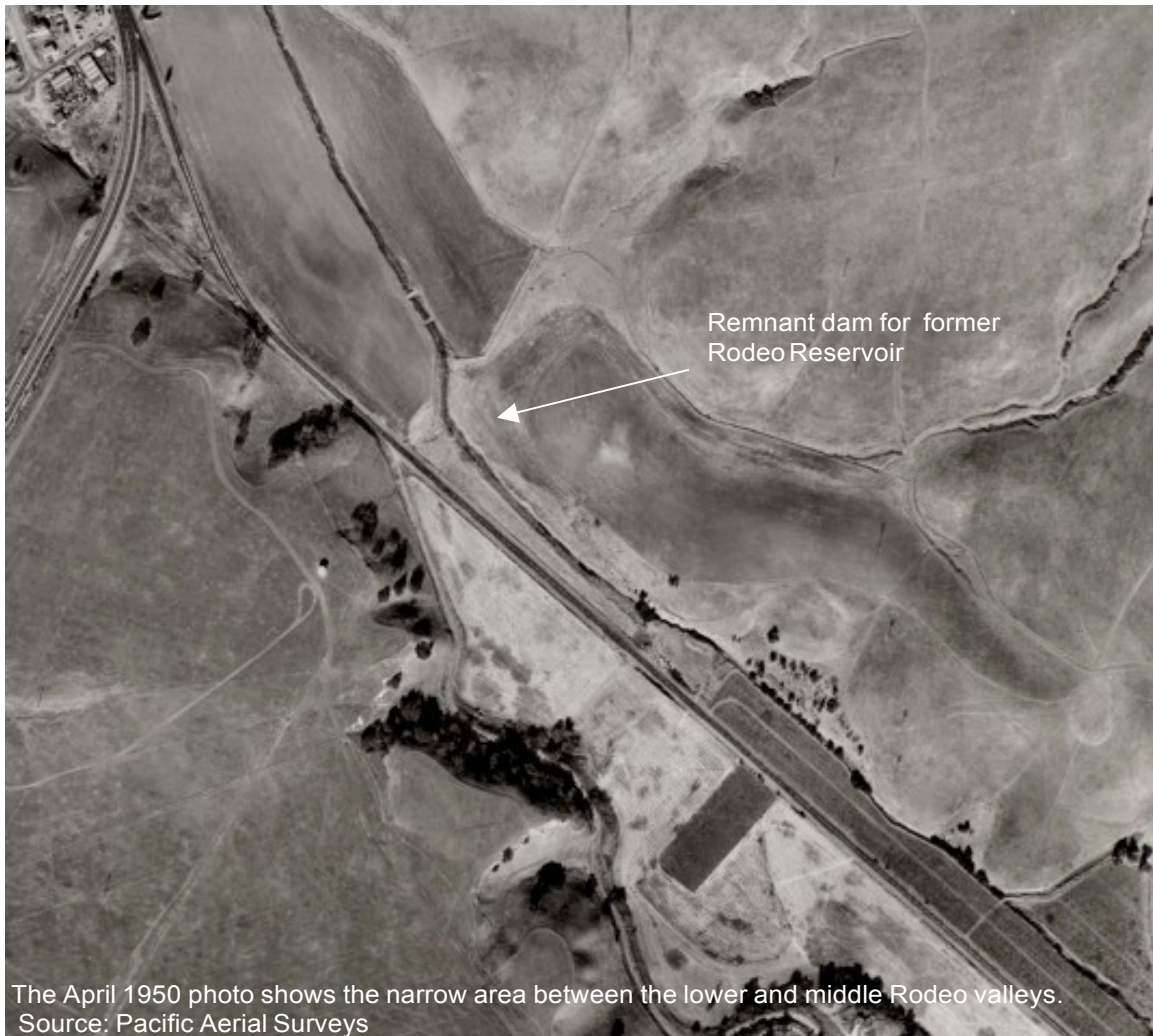
Apr 1950 – The photo below shows the location of the remnant dam for Rodeo Reservoir before the site was later used as fill for Highway 80.

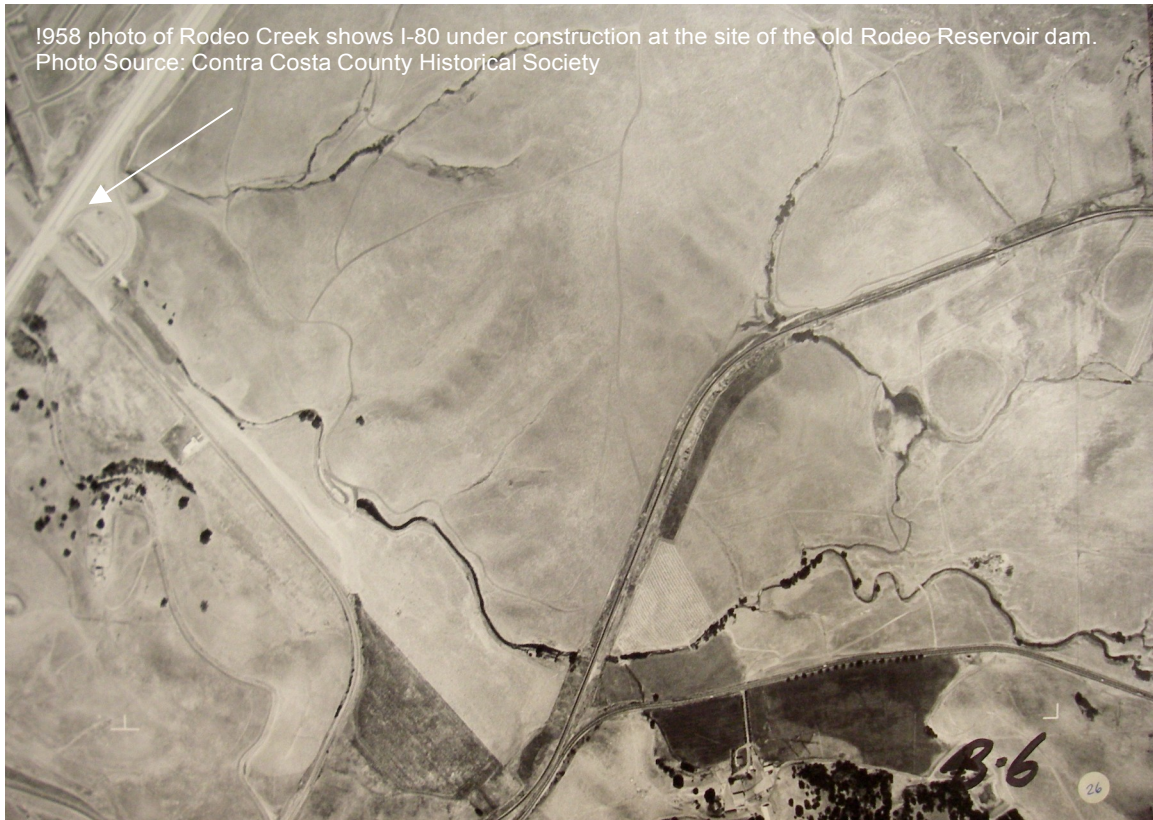
The 1958 photo below shows the beginning of construction for I-80 at the old Rodeo dam site in the upper left corner of the picture. The photo indicates that coffer dams were constructed upstream of the highway fill. The Santa Fe/Burlington Northern Railroad crossing can be seen in the middle of the photo. Note the lack of vegetation throughout most of the channel length.
