WILDCAT CREEK WATERSHED

A Scientific Study of Physical Processes and Land Use Effects

June 2001

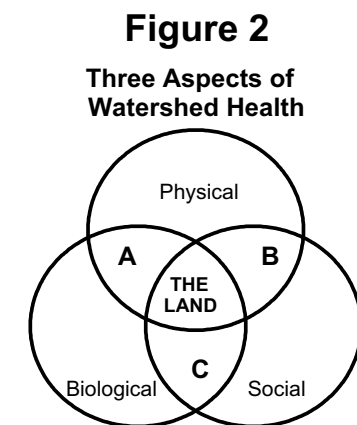
Multiple views can be useful in watershed science. For example, physical and biological views (A) are needed to describe habitat. Physical and social views (B) are needed to define flooding and landslide hazards. Biological and social views (C) are needed to define water quality and sediment toxicity. The land might be regarded as everything viewed from all three perspectives.

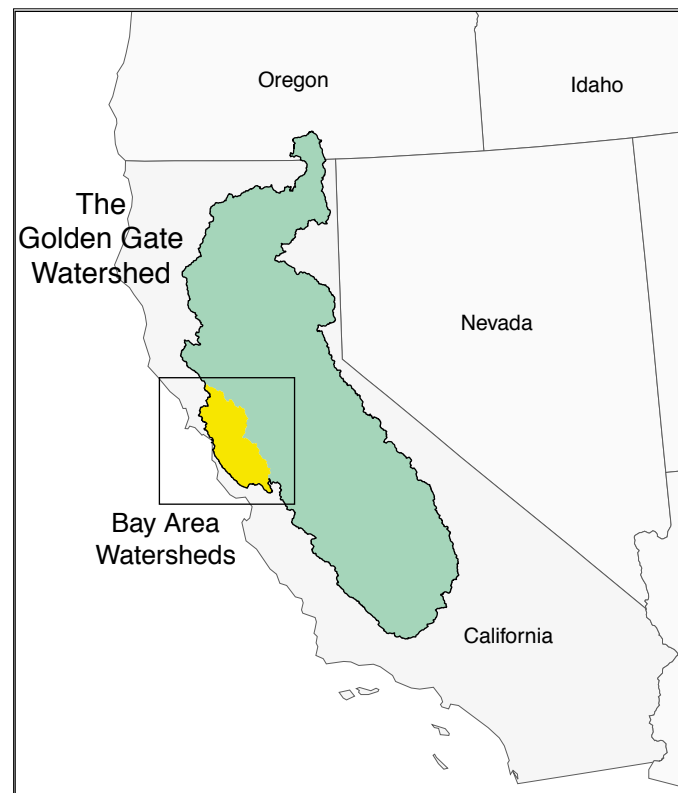
Figure 3. Golden Gate Watershed

Bay Area watersheds are part of the greater Golden Gate Watershed that drains much of California.

Wildcat Creek is one of many streams of the greater Golden Gate Watershed (Figure 3), which includes all the lands that drain through the San Francisco Estuary and the Golden Gate and into the Gulf of the Farallones.

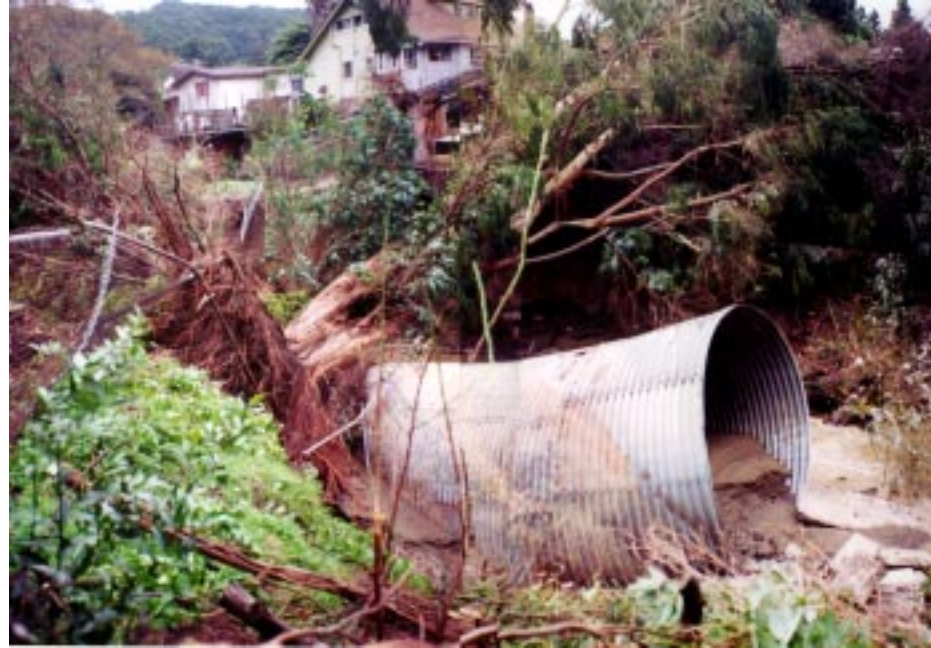
(Photo 3) A deteriorated 15 ft diameter culvert fails along with its overlying fill in the Upper Alluvial Plain Segment, January 1997.

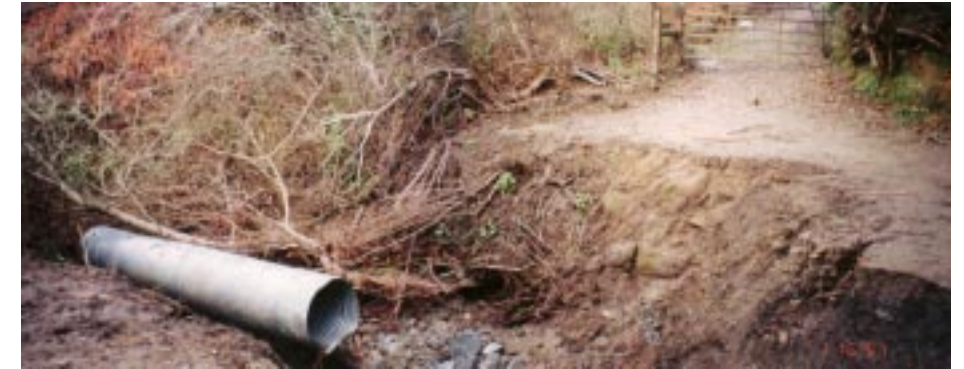
(Photo 4) A 3 ft diameter culvert fails along the Havey Creek Trail in the Lower Canyon Segment, January 1997.

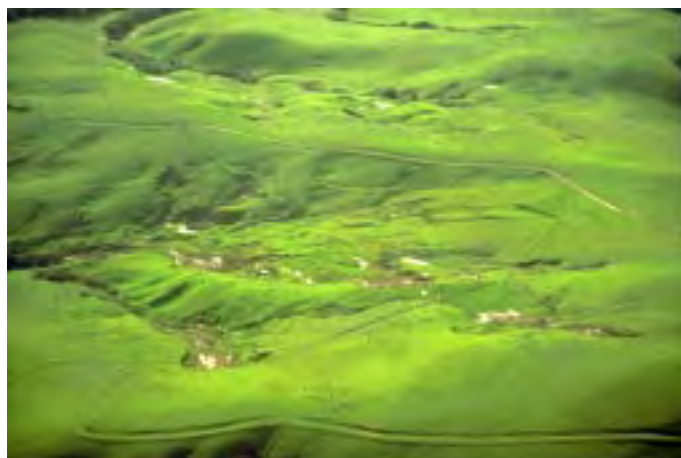
(Photo 17) February 1983, compound landsliding in the same area shown to the right, Site A.

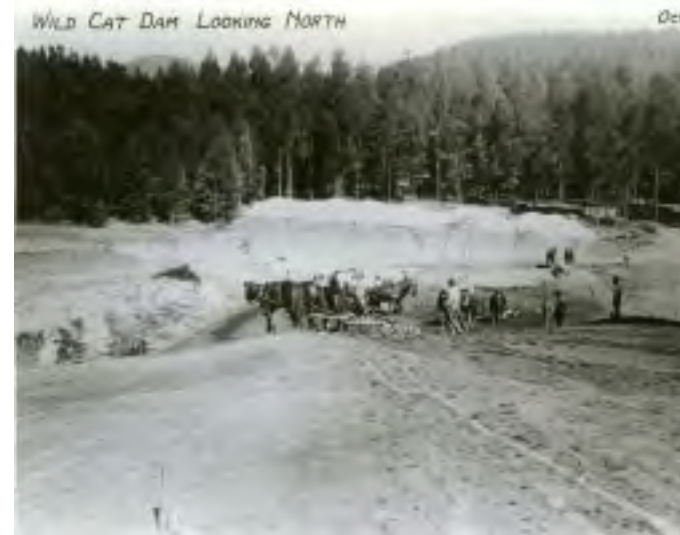
(Photo 19) Construction underway at Wildcat Reservoir (Jewel Lake) 1919. Consider the amount of sediment production and downstream impacts from these disturbed soils. Channel incision downstream of the dam and subsequent sediment production has been ongoing. Source: East Bay Regional Park District.

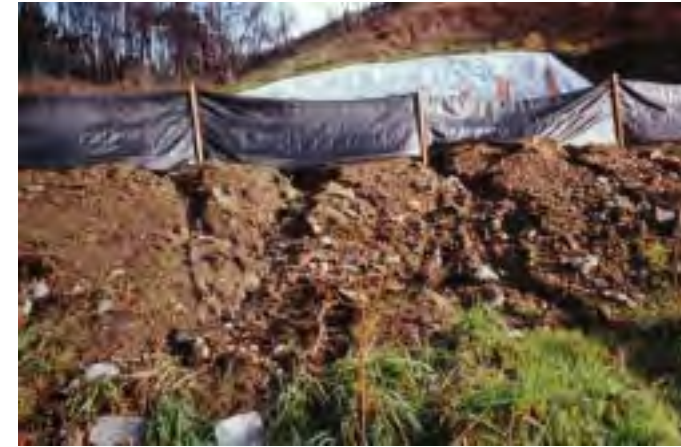
(Photo 20) Construction site erosion in disturbed soils. Soils that have been mechanically disturbed are more susceptible to erosion than soils that are bare but still have small rootlets intact. (Booker et al. 1993) Such a situation may occur after burning, grazing or application of herbicides.

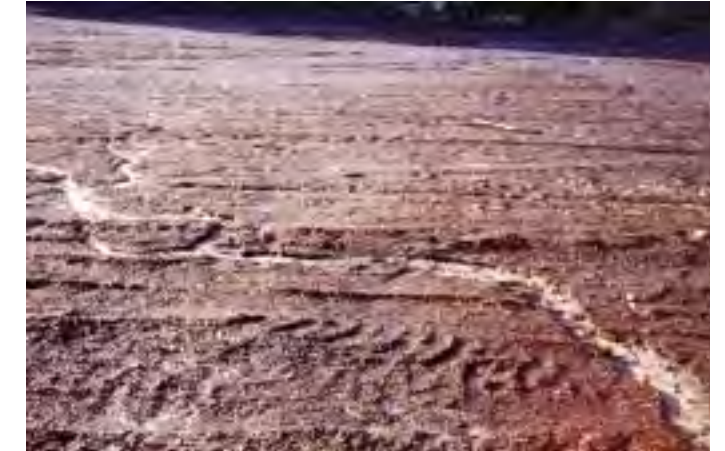
(Photo 21) An example of rill erosion in soils prepared for sod in Alvarado Park. Consider the amount of sediment production during preparation of the Tilden golf course during the late 1930s.

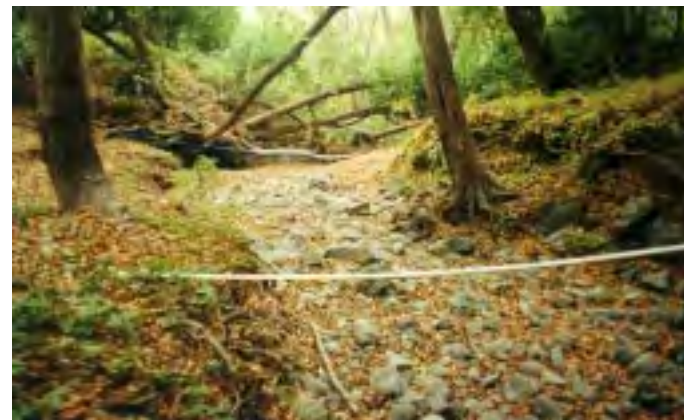
(Photo 22) (a) August 1994. A tree has fallen across the channel during the dry season. The bed is mostly coarse cobble due to a reduced supply of fine sediment during the previous 7 yrs. The banks are sharp-edged. The bed has been incising since 1986. (b) April 1995. Two significant flood flows occurred during January and March. The peak flow was the second highest in 33 yrs. Heavy rains activated landslides, providing large woody debris that were mobilized by floods. A debris jam has formed at the fallen tree (see photo a). The dominant bed material changed from cobble to sand. A gravel bar 4 ft high formed behind the jam. The standing alders are freshly scarred from being rammed by floating debris (see trunk left foreground).

The four photos below illustrate typical changes in mainstem channel conditions within the Canyon over a 5 yr period from 1994 through 1999. Each photo is looking downstream from approximately the same left bank position. Peak annual flows had been moderately low for 7 years preceding photo 22 for 1994. Flows greater than 1000 cfs occurred during 1995, 1996, 1997, and 1998.

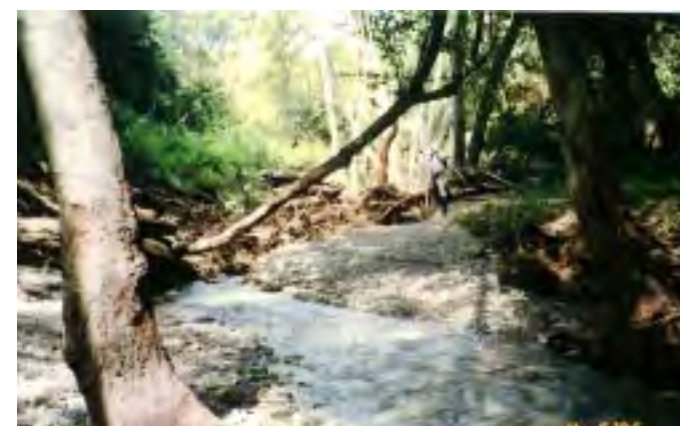
(Photo 23) (b) April 1995. Two significant flood flows occurred during January and March. The peak flow was the second highest in 33 yrs. Heavy rains activated landslides, providing large woody debris that was mobilized by floods. A debris jam has formed at the fallen tree (see photo 22). The dominant bed material changed from cobble to sand. A gravel bar 4 ft high formed behind the jam. The standing alders are freshly scarred from being rammed by floating debris (see trunk left foreground).

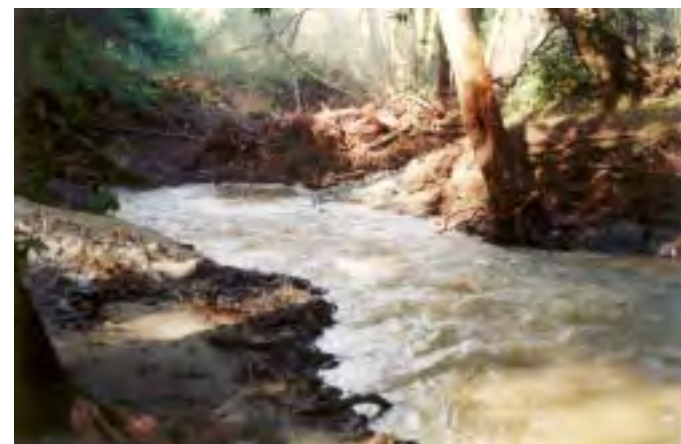
(Photo 24) (c) January 1997. The debris jam has collected more woody debris, but the channel has cut around the jam on the left, releasing the sediment that had deposited behind the jam. Much of the bar has eroded away. Sand from local landslides is beginning to cover remnants of the bar (see bar top left foreground).

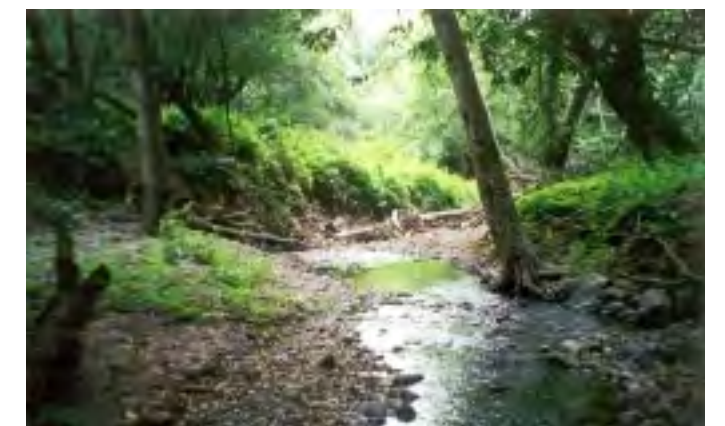
(Photo 25) (d) June 1999. The debris jam has almost completely deteriorated. The gravel bar and its sandy cover have mostly washed away. The bed material is generally finer and the bed is higher than in 1994 (see photo 22). The banks are not as steep. The large alder (see left foreground photo 23) has been broken at its trunk and washed downstream.

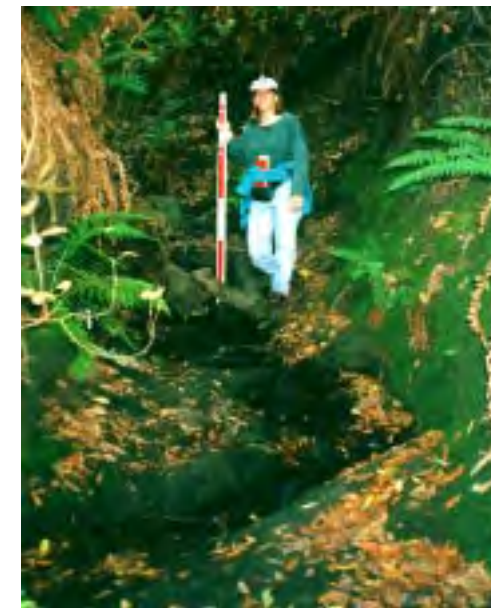
(Photo 26) An incised tributary channel in bedrock that drains the east-side grasslands.

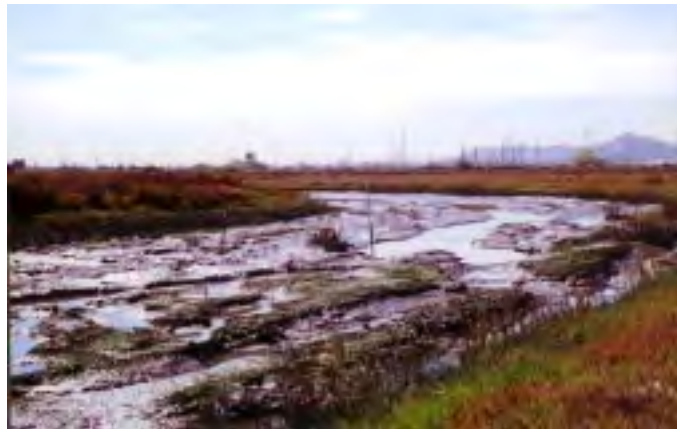
(Photo 28) Looking downstream at the tidal reach that has old levees along its banks. This reach is represented in cross section "B" in Figure A (see facing page).

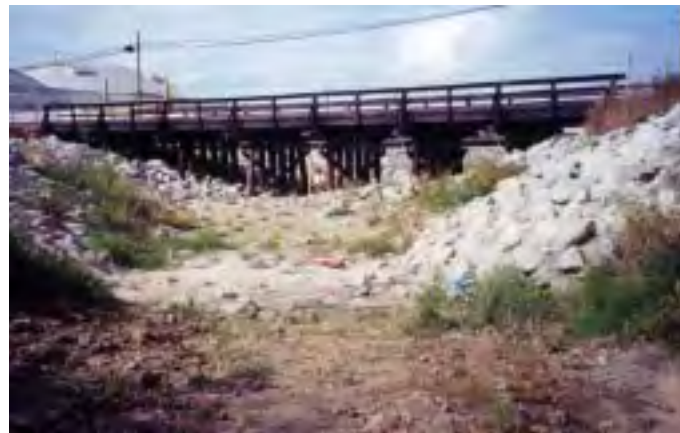
(Photo 29) Looking downstream at Santa Fe Railroad trestle and rip rapped trapezoidal banks of the flood control project, as represented in cross section "F" in Figure A (see facing page). The grouted rip rapped corresponds to the aggradation shown in Figure 89, page 69.

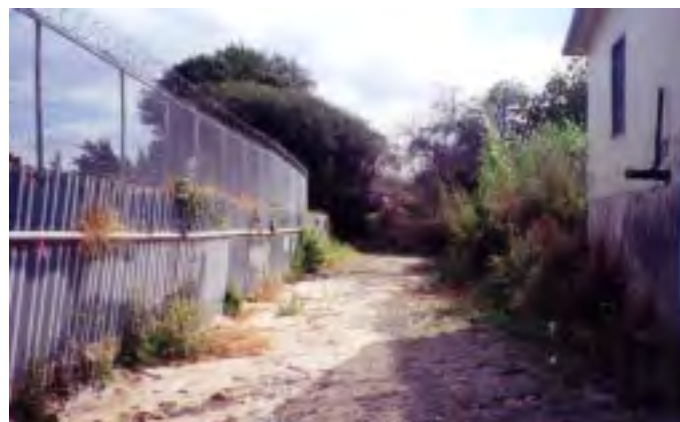
(Photo 30) Looking upstream from the Rumrill box culvert at the plain bed of the creek that lacks topography. This reach is represented in cross section "I" (which is drawn looking downstream) in Figure 49.

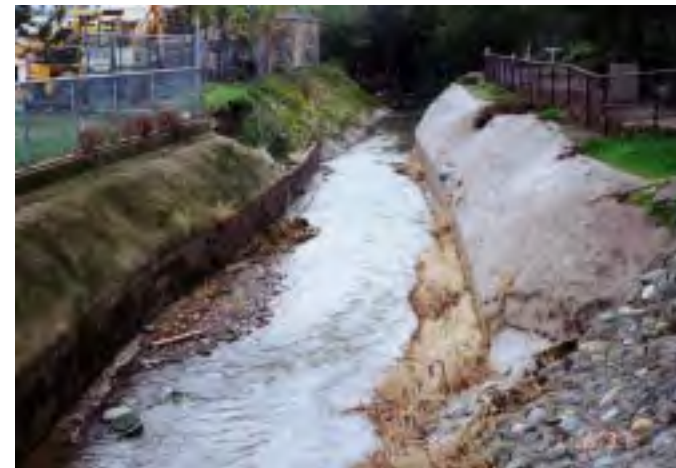
(Photo 31) Looking downstream at revetted channel at Davis Park, which floods with flows that have a recurrence interval of less than 10 yrs. This area is represented by cross section "K" in Figure 49 (see facing page).

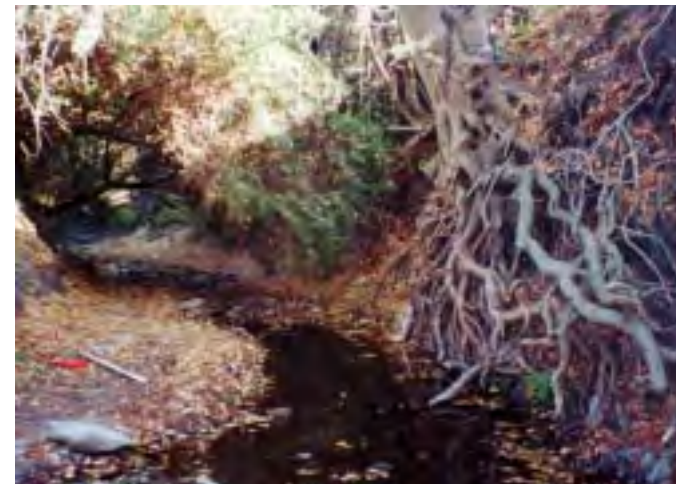
(Photo 32) Looking upstream at the exposed roots of a buckeye tree that indicates recent bank erosion, as represented by cross section "P" (which is drawn looking downstream) in Figure 49 (see facing page).

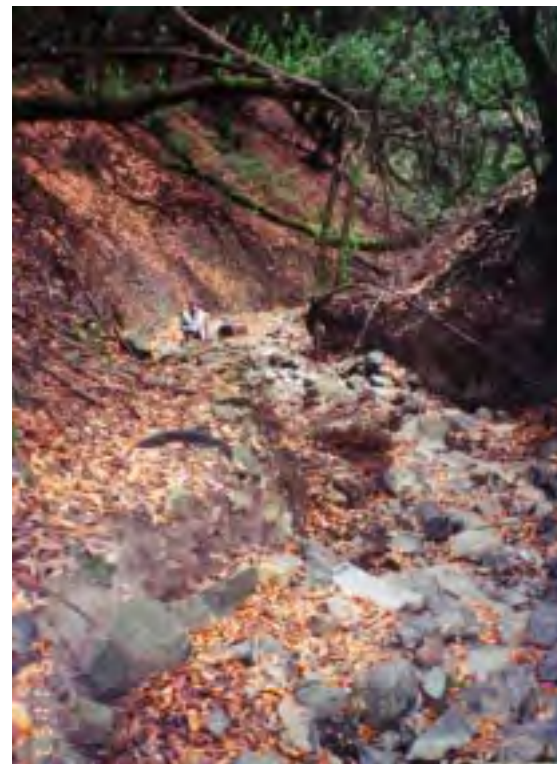
(Photo 33) Looking downstream at mainstem Wildcat Creek between cross sections Z1 and Z2 (Figure 49). The channel is dominated by volcanic cobble from debris flow deposits that armor the bed.

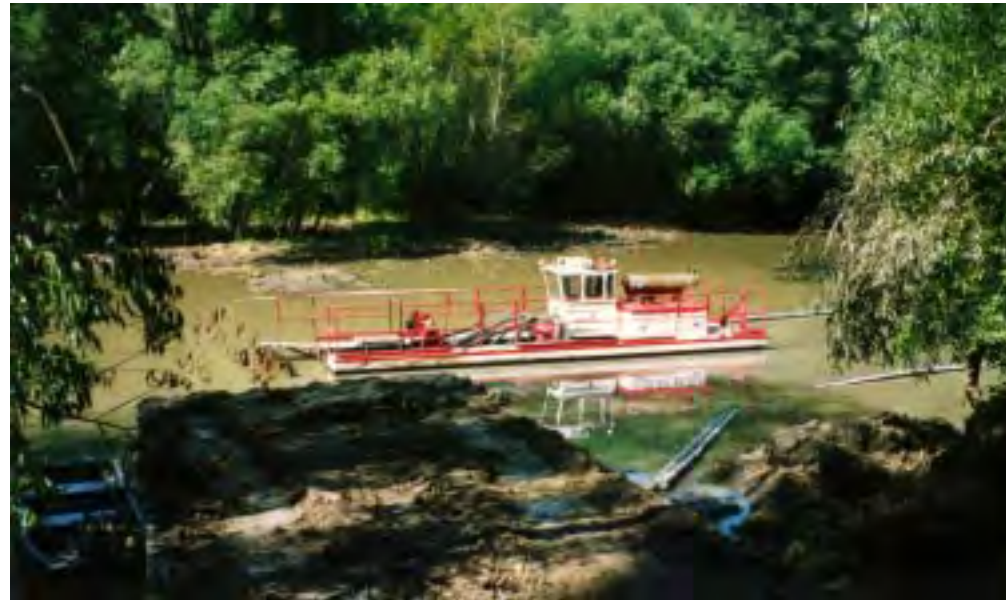
(Photo 35) Dredging Jewel Lake in 1991.

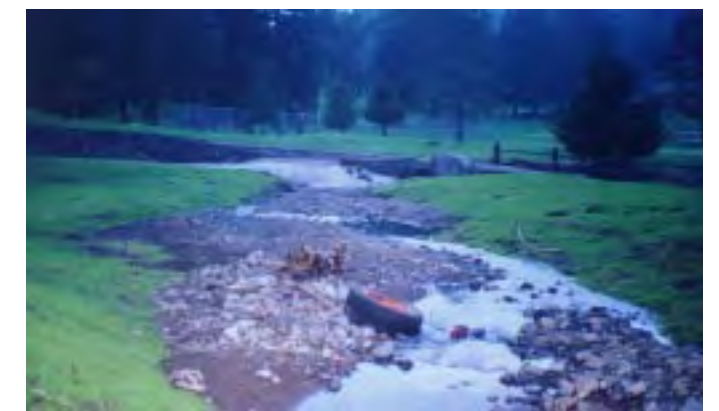
(Photo 36) Some sediment is deposited in the Tilden Golf Course upstream of the mainstem sediment basin.

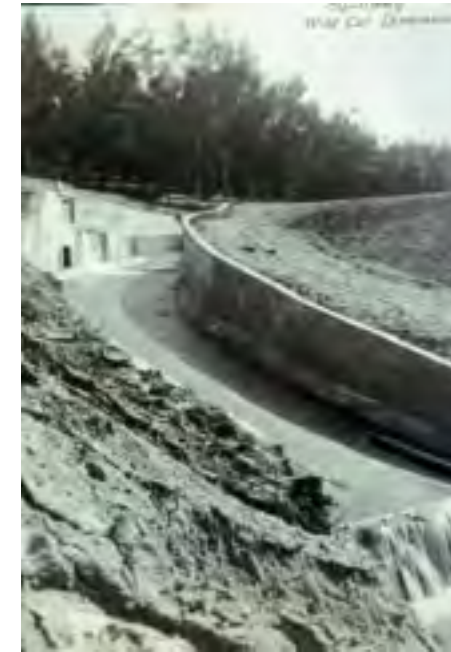
(Photo 36a) The edge of the newly constructed dam at Jewel Lake, 1922. Note there is about 2.5 ft of fall.

tial influence beyond Havey Creek confluence, which is the first substantial tributary that supplies significant bedload downstream of the dam. A substantial amount of incision is caused by the withholding of sediment by the reservoir. The channel below the spillway has incised 12 ft from the time it was constructed in 1922 (Photos 36 and 37). We have calculated the bed incision supply from the effects of the dam to be 233 cu yd/yr (Table 13).

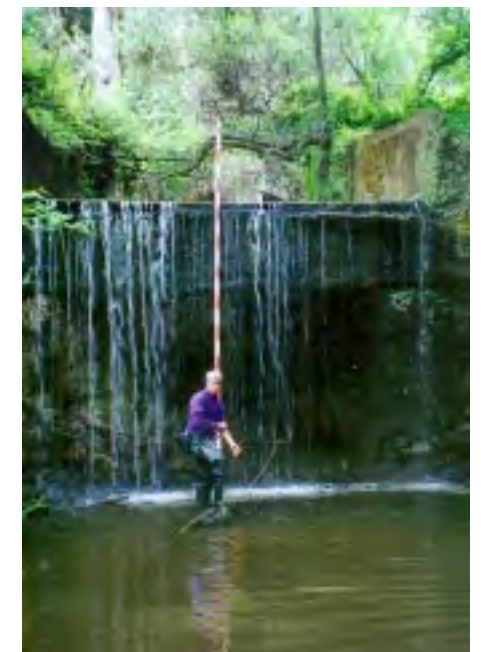
(Photo 36b) The edge of the spillway in 1999 has over 14 ft of fall.

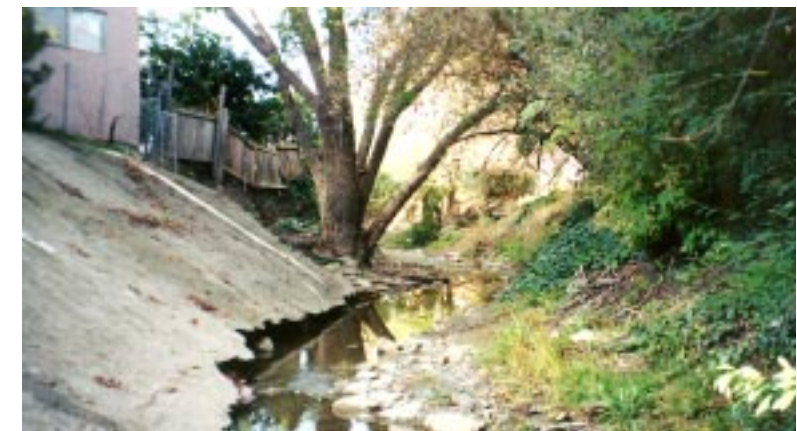
(Photo 38) A revetted bank and a natural bank oppose each other along the Alluvial Plain. Bed incision within the last 50 years is apparent along the base of the concrete and at the exposed roots on the right bank.

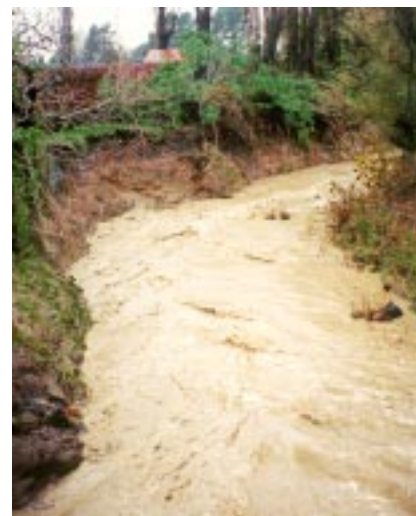
(Photo 39) The waning flood flow of January 1997 exposes an eroding left terrace bank near Vale Road.

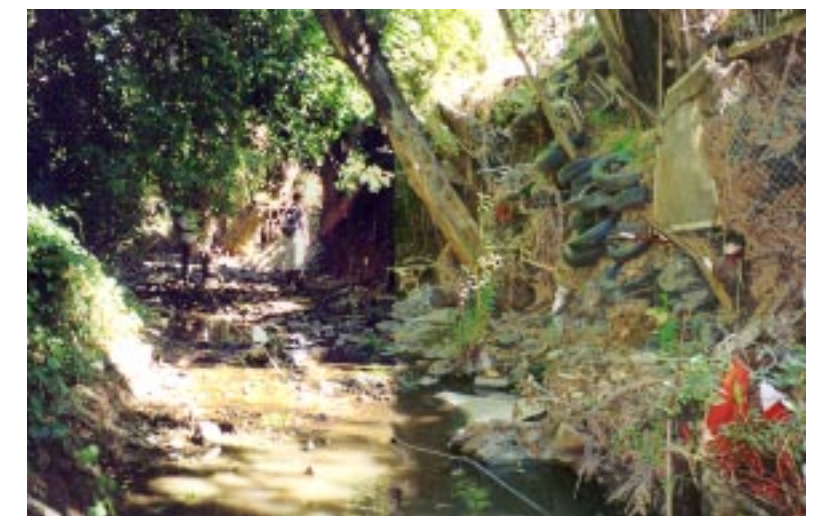
(Photo 40) Non-engineered revetment is failing into Wildcat Creek.

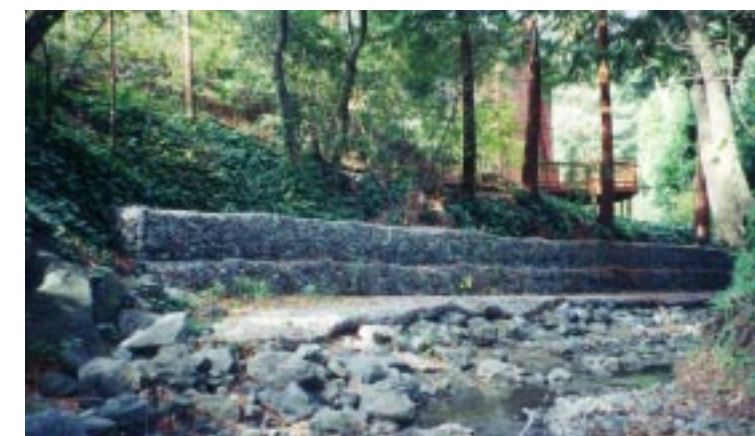
(Photo 41)
A new wire basket gabion and apron revetment in McBryde Reach, January 1998.

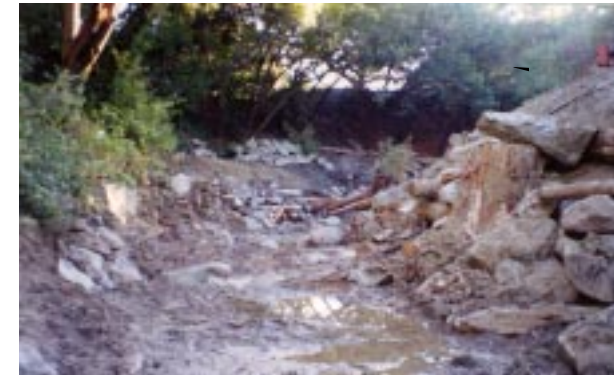
(42)

(Photo 42) 1997, root wad and boulder revetments were used in Alvarado Park for revision of the restoration project. Note the position of the boulder on the right bank tree stump at the arrow. Photo was taken shortly after construction.

In the Lower Canyon, only 5% of the total length of the banks is revetted (Figure 56a, page 52). Riprap exceeds the amount of concrete by 8% (Figure 60b) in the Canyon. About 69% of this revetment is located in Alvarado Park (Figure 60a), where much was put in after a restoration project was conducted to remove two small dams. Additional amounts were constructed a few years later.

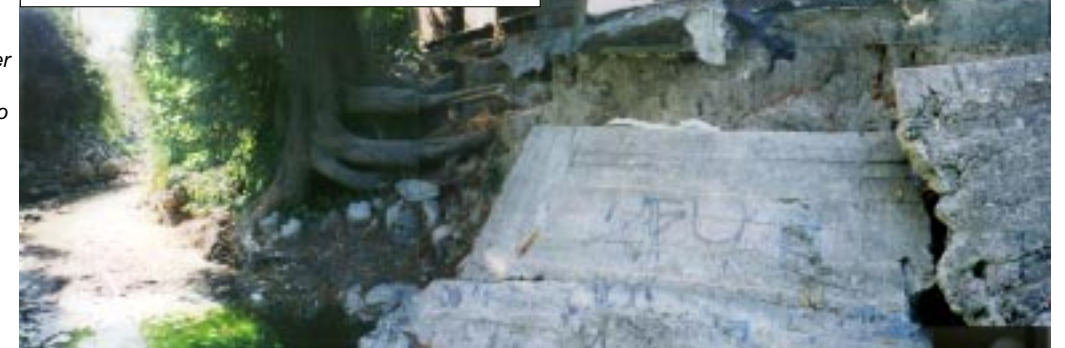
(Photo 43) 1998, same view as photo 1, but one year later. Right bank revetment has slumped about 4 ft into channel. Note the position of the boulder on the stump at the arrow.

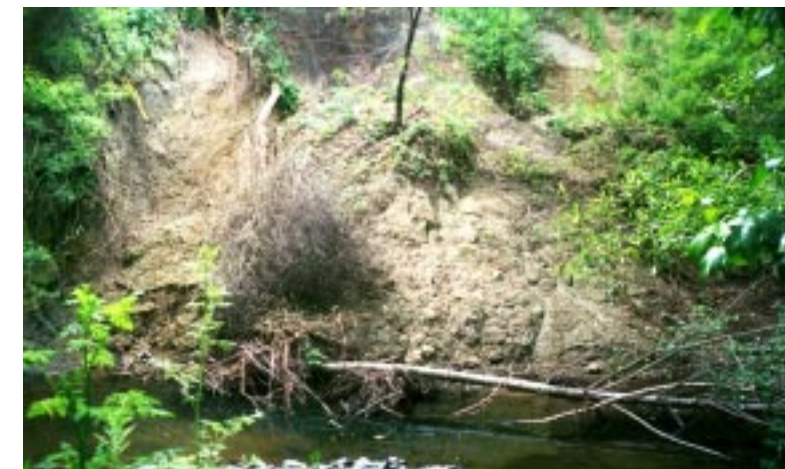
(Photo 45) Direct sediment input to the channel from the reactivated toe of an earthflow, June 1999.

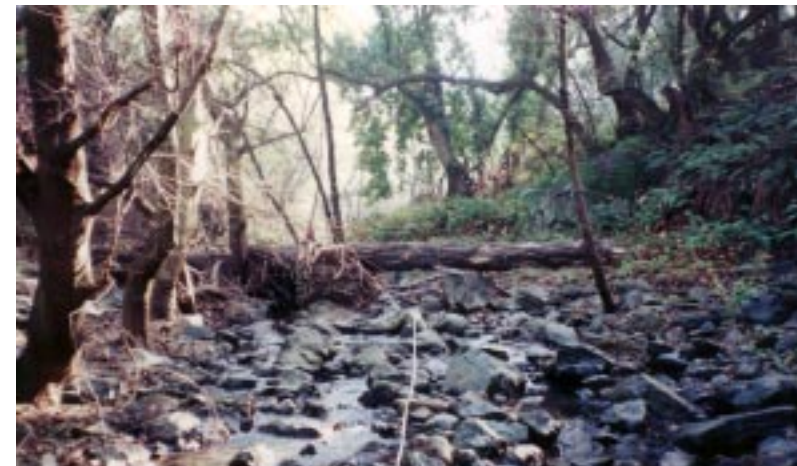
Figure 67. Geomorphic Map Detail of Wildcat Creek

This detailed Creek Map of Geomorphic Process (Figure 67) shows the anatomy of Wildcat Creek along a 215 ft-long reach of stream about one quarter mile downstream of Jewel Lake dam. The map accurately portrays the characteristics of plan-form, bankfull width, vegetation, and woody debris. In particular, it shows patches of sediment that have been sorted both laterally across the channel cross-section and longitudinally along the creek meanders. Patches of sediment that have been sorted into different size classes can be quantified by performing modified Wolman pebble counts

(Wolman, 1954) where the average particle size (D50) is determined by statistical analysis. The method is modified by restricting the count to patches rather than averaging the entire bed. As can be seen from Figure 67, the channel bed is often characterized by different D50 size classes across its cross-section.

When sediment supply is high, the bed tends to become finer in dominant grain size. When the sediment supply is low, the bed tends to coarsen. We have made these observations by comparing the 1987 maps to conditions observed during various reconnaissance surveys. Comparisons of earlier geomorphic maps of Wildcat Creek indicate that the high sediment supply from the years of 1882, 1983, and 1986 caused the bed to be patchier with more size classes and dominated by finer size classes. During the following years of low sediment supply, the bed coarsened and became less patchy. Following the wet season of 1998, the channel bed showed an increase in fines and patchiness again.

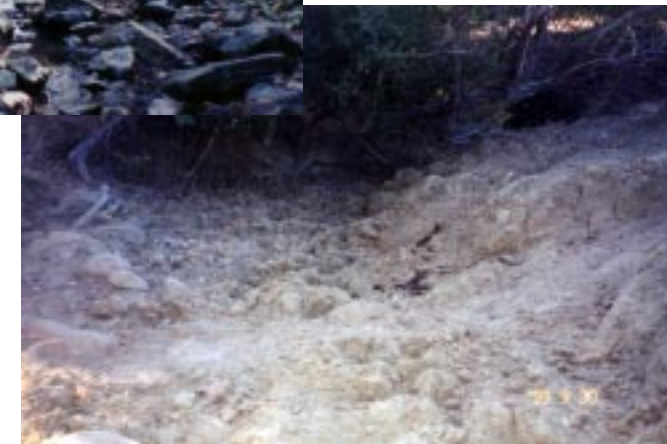
(Photo 46) A length of the mainstem Wildcat Creek in the Lower Canyon dominated by cobble-sized sediment.

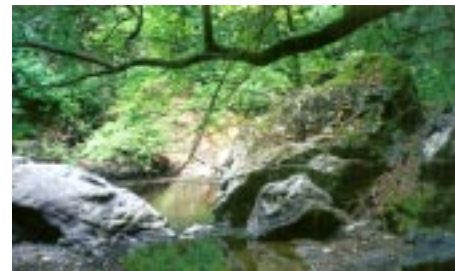
(Photo 48)
 A deep pool is formed by scour around boulders.

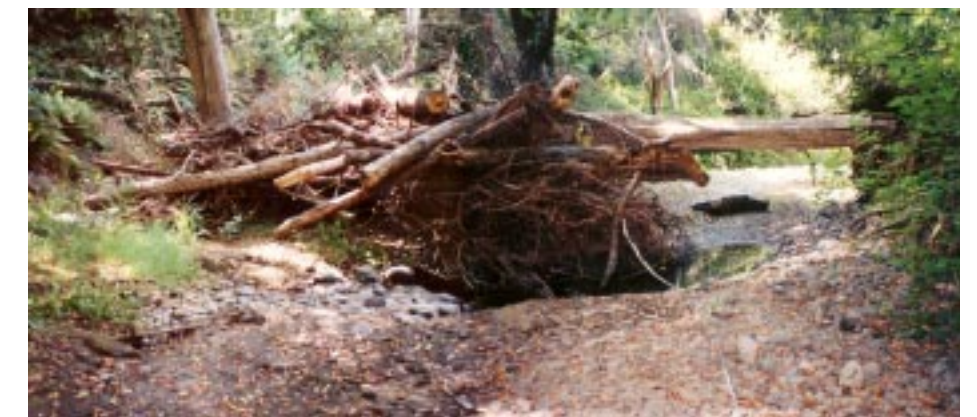
(Photo 49) A pool is formed by scour over a debris jam.

Pools have a natural frequency of occurrence associated with their meander bends. Surface waters forced toward the outside bend of a channel create a scour pool, while sediment is transported toward the inside bend forming a point bar. When there is an abundance of pools with spacing less than the expected 5–7 bankfull channel widths, the “extra” pools are often created by scour from flow obstructions not associated with the meander. Large woody debris, boulders, and bedrock, are common pool-forming obstructions.

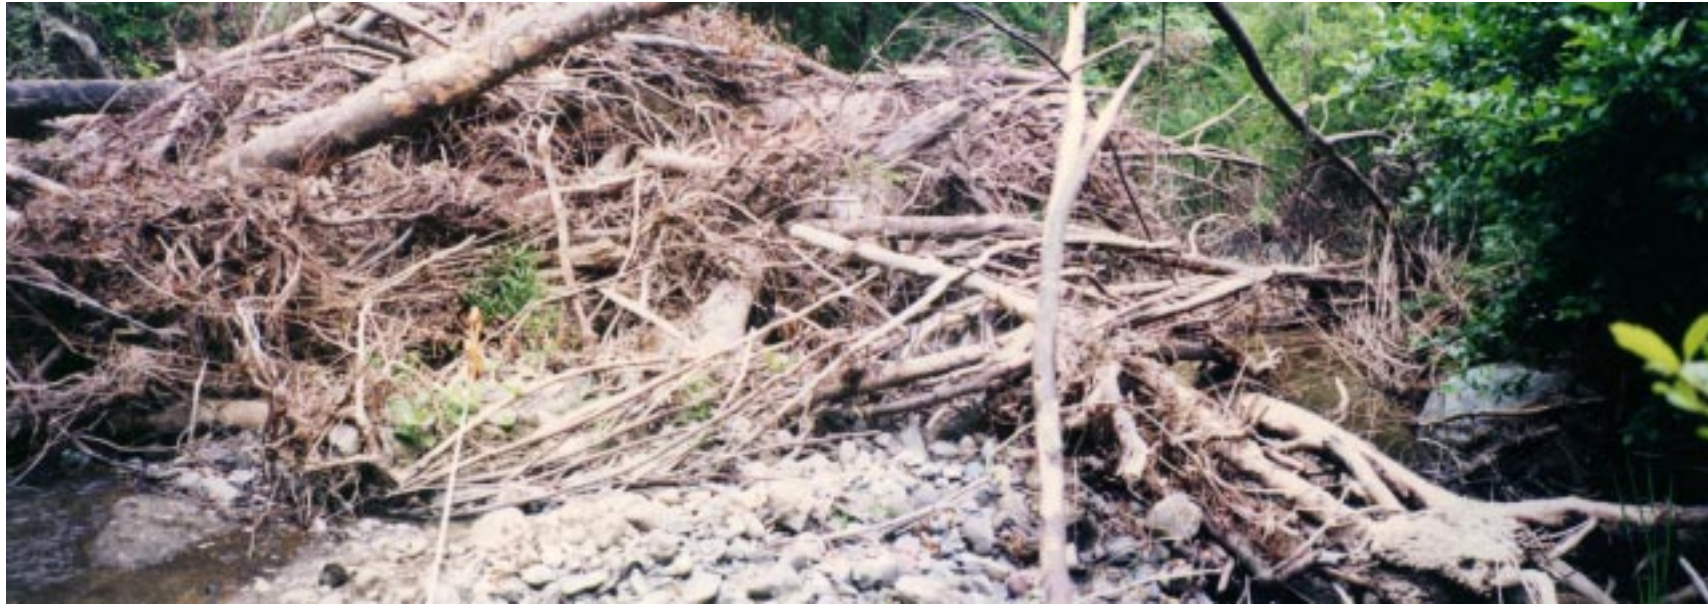
(Photo 50) An accumulation of different types of woody debris stores upstream sediment.

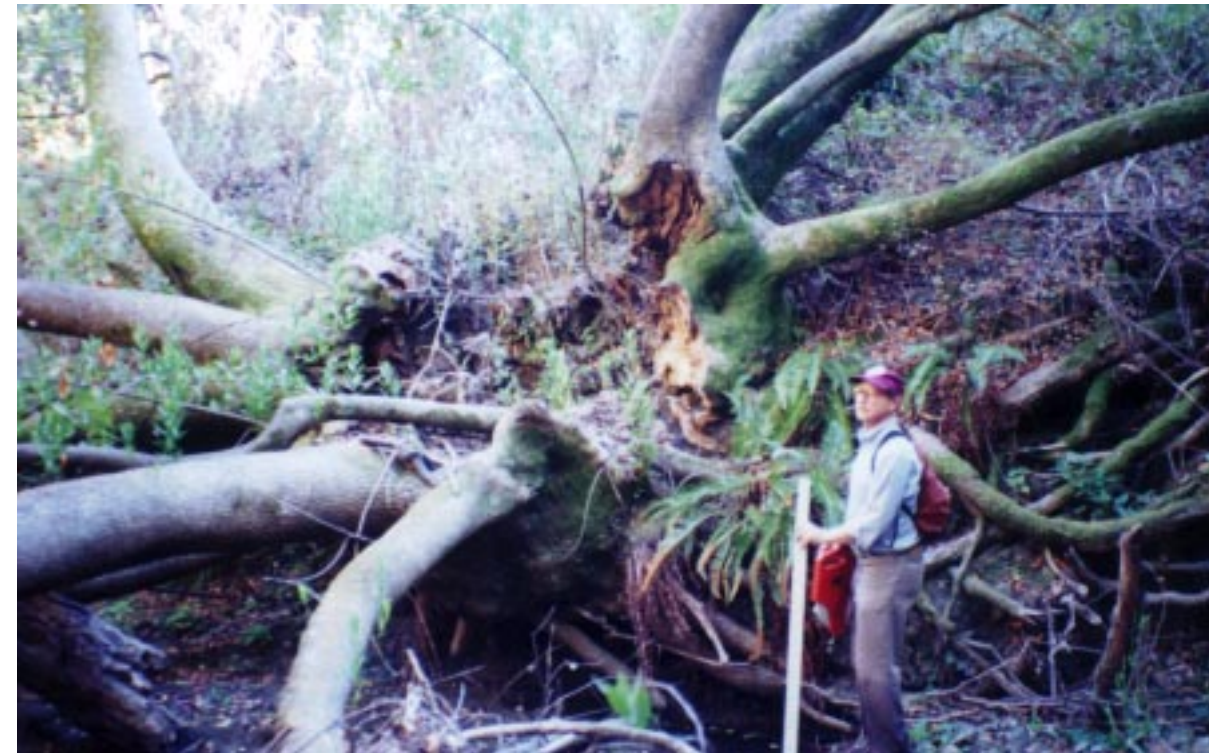
(Photo 51) A bay tree splits apart in 1996 summer after suffering severe rot from a fungal disease that attacked many trees. This was an important mechanism of woody debris recruitment of this species.

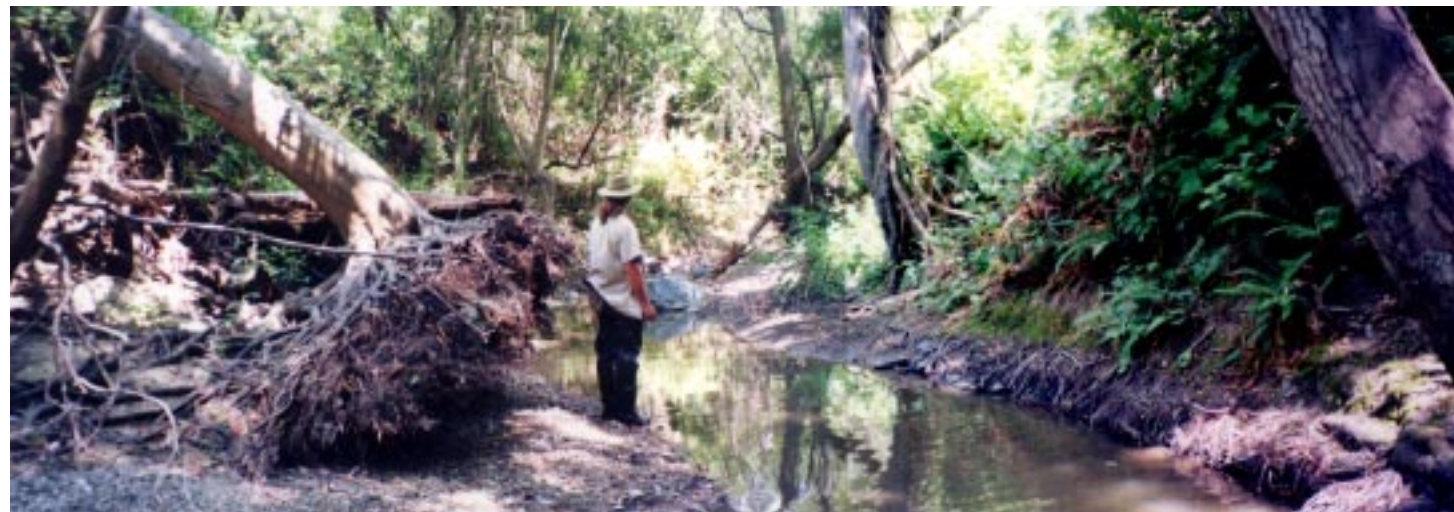
(Photo 52) Some alders are literally ripped from their beds when large floating debris rams into them during floods, May 1997.

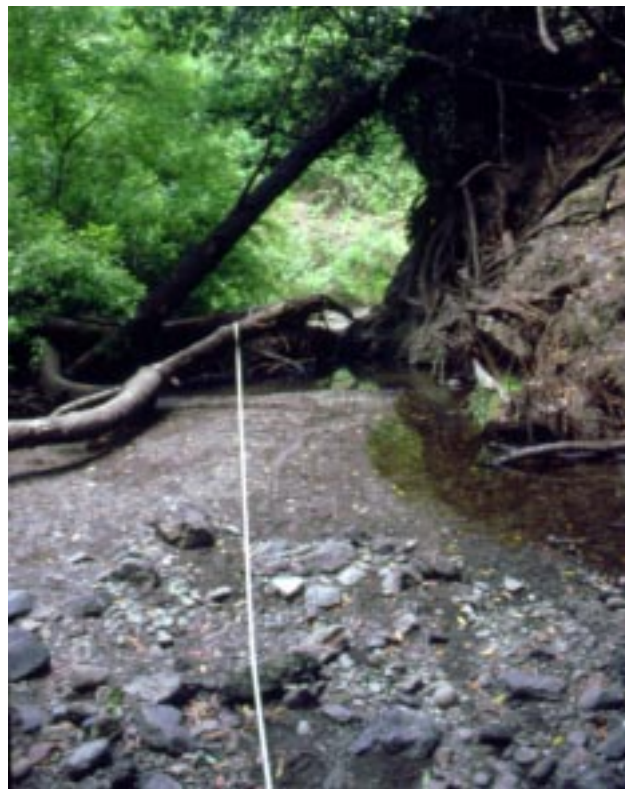
(Photo 53) Large woody debris is recruited to the channel by fluvial erosion of the banks.

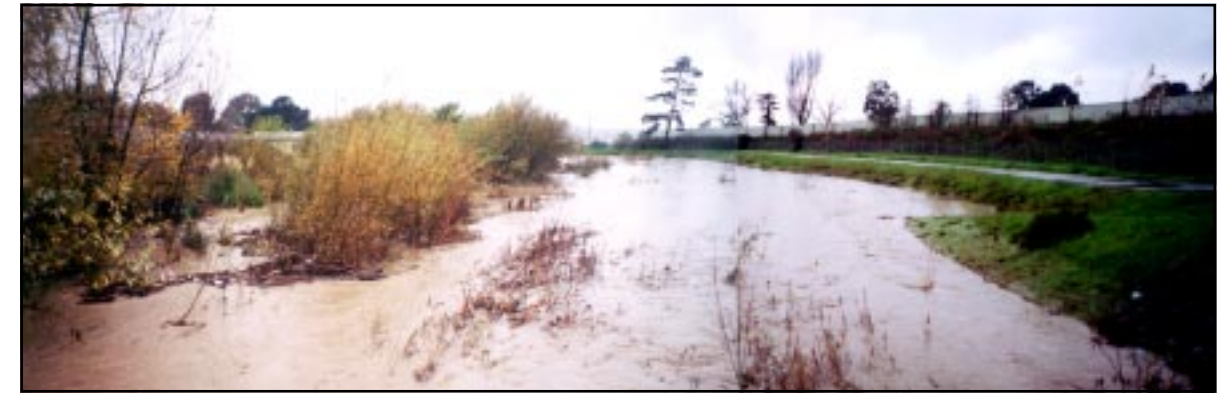
(Photo 54) The waning flood of January 1997 in the trapezoidal flood control channel divides between the constructed bankfull channel on the left and the constructed flood plain on the right. Debris has collected at the entrance of the low flow channel.

In 1996, the Waterways Restoration Institute excavated a new channel through the riparian reserve from the Richmond Parkway up to Verde School. The natural meander pattern established by the creek was recreated in a channel that was made as deep as possible (up to 4 ft) at a width of 10-15 ft. Monitoring after winter storms indicated that the channel was efficiently transporting sediment and not filling (Waterways Restoration Institute, 1999). Unfortunately, during maintenance operations in 1998, the County excavated the bed of the inner floodplain below the bed level of the bankfull chan-

nel. Subsequently, bankfull flows were diverted from the constructed bankfull channel to the over-excavated floodplain. The bankfull channel filled with sediment. The undisturbed downstream sections of restored bankfull channel have had sufficient flows to maintain their designed geometry to date.

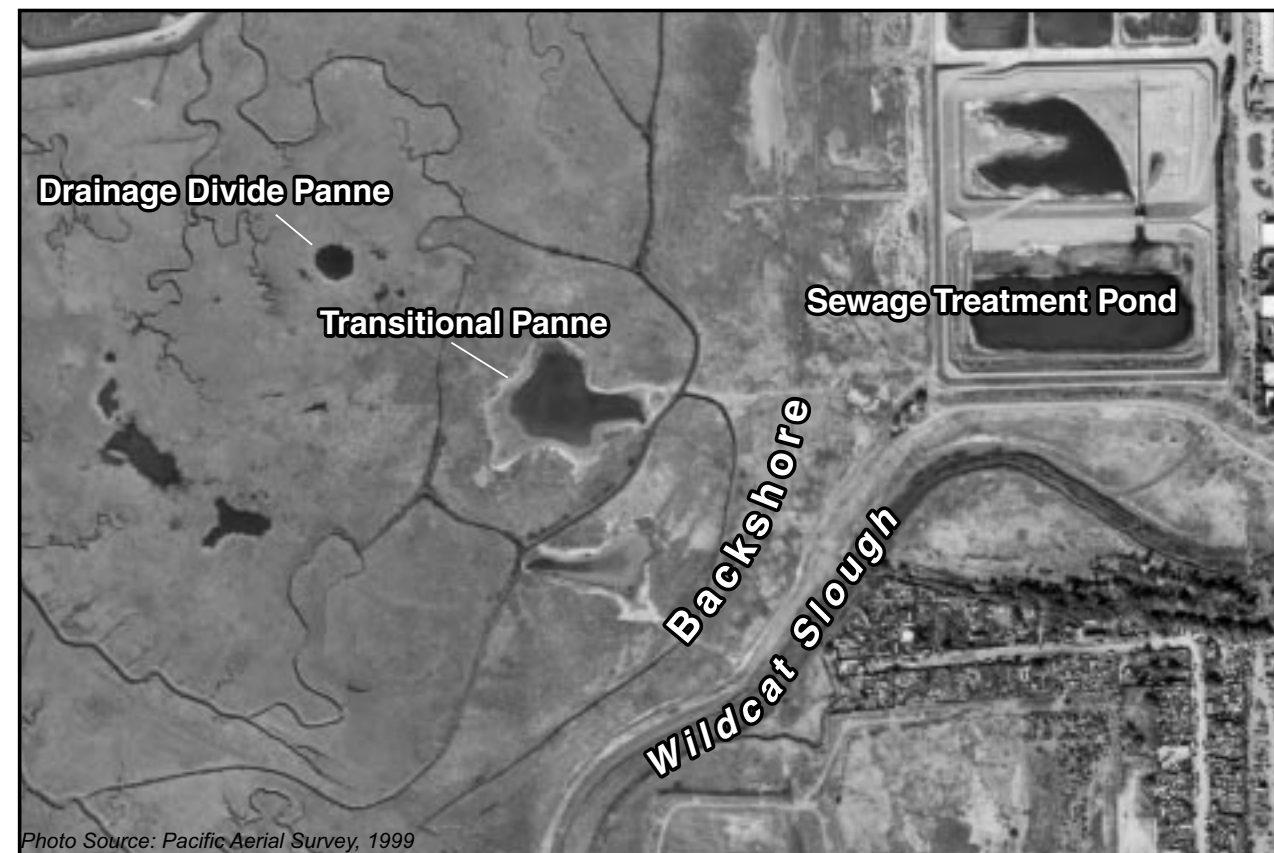
Figure 82. A Detail of Wilcat Marsh

The baylands consist of mudflats, tidal sloughs, natural levees along the largest channels, the foreshore of the tidal marsh, the marsh plain, tidal marsh pannes, and the backshore of the marsh (Figure 82) (Goals Project, 1999). The mudflats gradually slope upwards from about mean lower low water to the vegetated foreshore. The elevation of the foreshore varies with plant species and wave height, but it generally approximates mean tide level at Wildcat Marsh. The mudflat innervates the marsh through the network of tidal channels. The largest channels have low levees. The elevation of the marsh plain varies slightly around mean high water. The plain slopes upwards at the backshore, where the marsh plain transitions into upland.

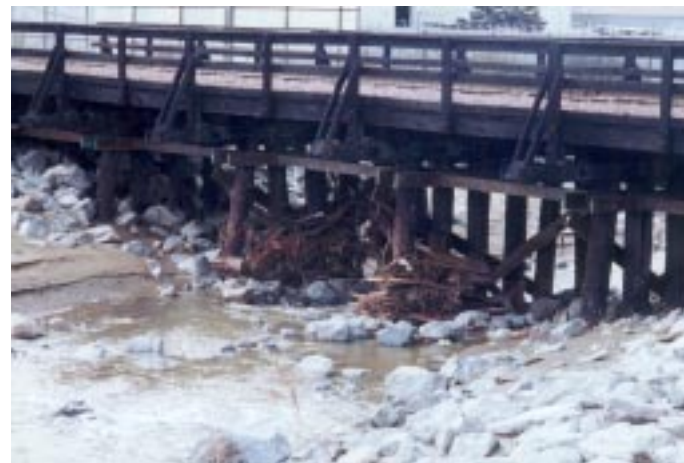
(Photo 55) Floating woody debris collects on the railroad trestle piers. The beams and the trestle impede the passage of flood flows and contribute to the formation of backwater floods. Flows have exceeded the top of the tracks.

effects of the trestle (see Photo 55, page 69). Floods have overtopped the trestle on several occasions.

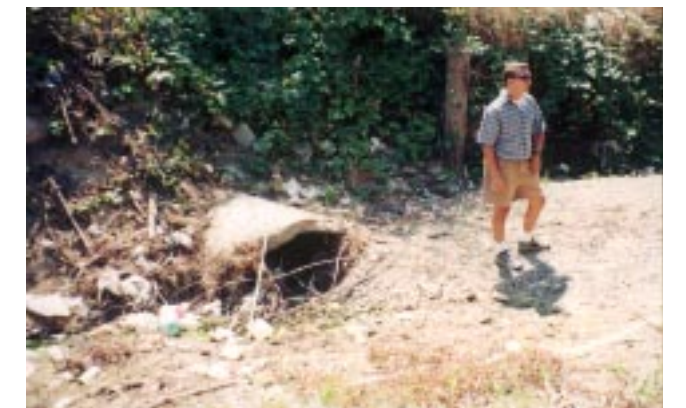
(Photo 56) A buried reinforced concrete pipe gives evidence of an aggraded bed. It is located near station 6200 on Figure A above.

Channel aggradation is still occurring in the area of the historical backshore of the tidal marsh, although tidal influence has been stopped thousands of feet downstream. There are four obvious reasons for this aggradation. First, the flood control basin is much less steep than the local historical gradient of Wildcat Creek, so it lacks the power to convey as much sediment. Second, the basin of the Flood Control Project was designed

to trap sediment at its upstream end, at about station 5000 ft. Third, the Rumrill Reach is trapping bedload because of a grouted riprap structure that has artificially elevated the creek bed. Fourth, there is occasional aggradation in this reach from debris jams and flood flows that transport of water and sediment impeded by the railroad trestle.

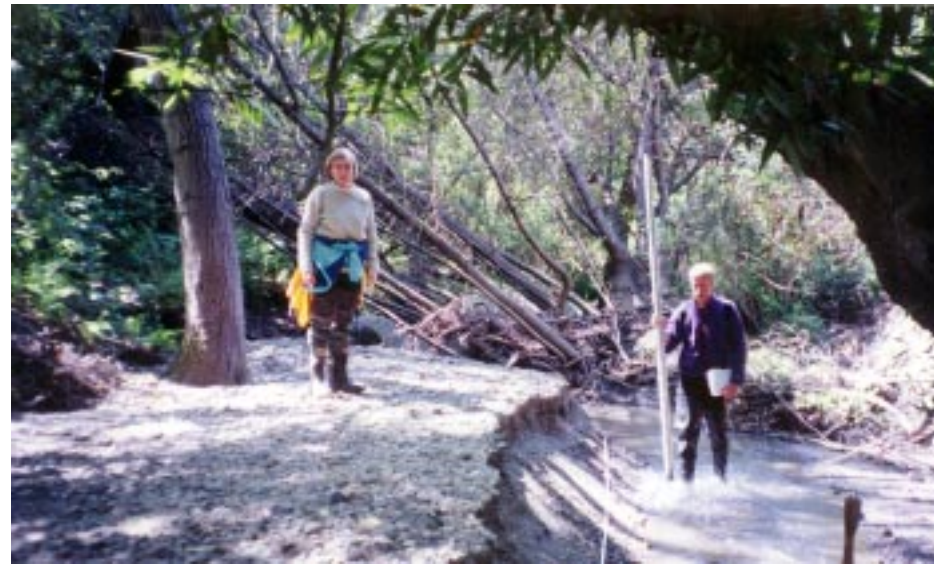
(Photo 57) Deposition of at least 3.5 ft has occurred behind a bay tree that slid into the channel, May 1999.

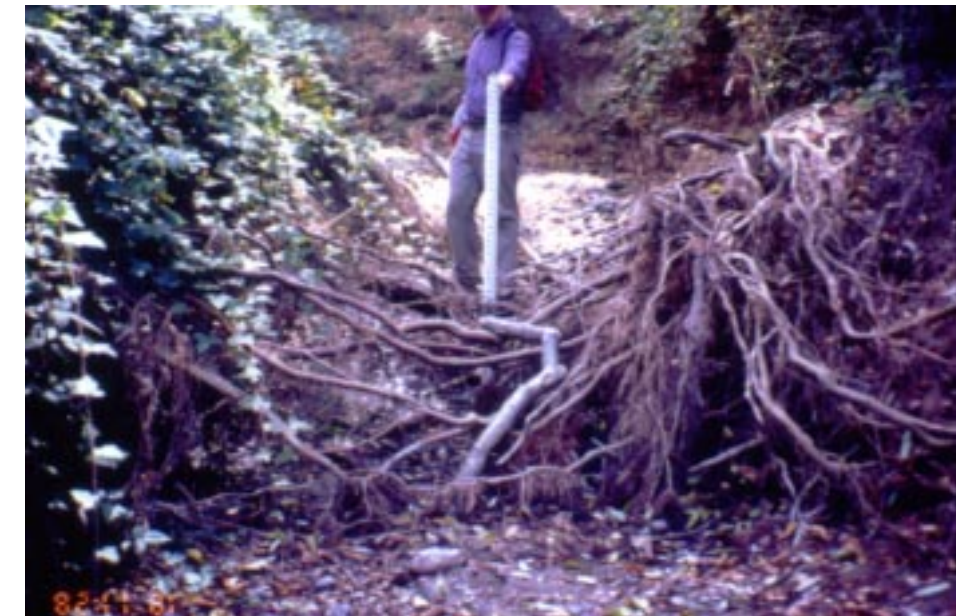
(Photo 58) Exposed roots in 1996 indicate the amount of bed incision that has occurred since 1987 when this reach was previously surveyed.

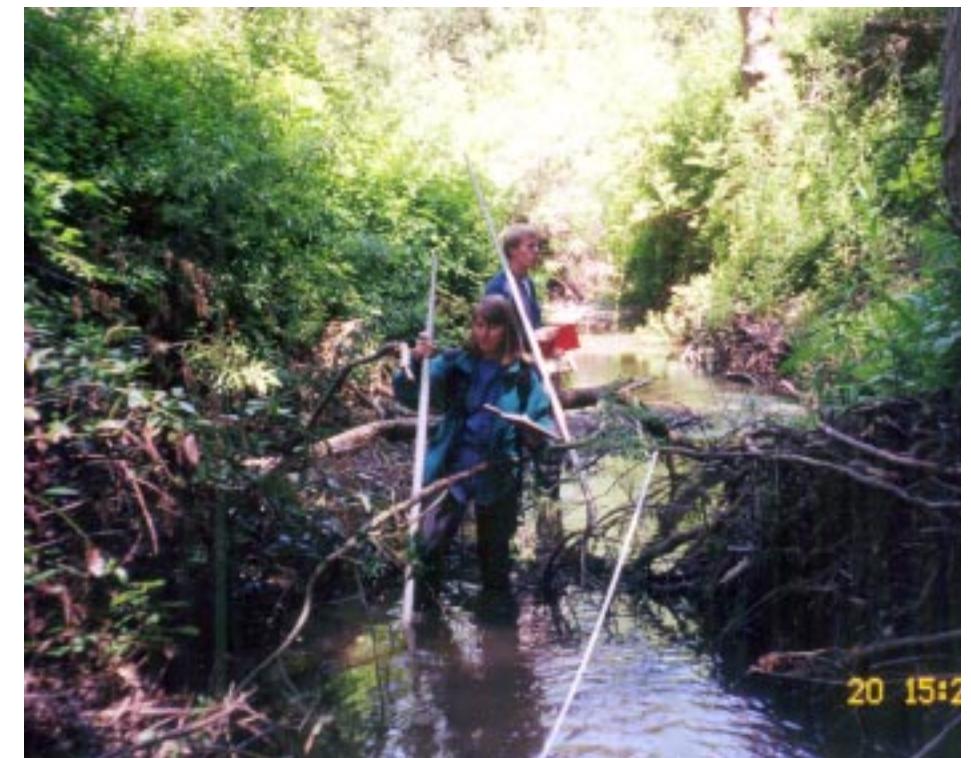
(Photo 59) The same set of roots in 1999 show continued bed incision by at least another foot since 1996.

The long-term mode for Wildcat Creek in the Canyon has been degradation. This is evident from the numerous abandoned terraces. Nowhere were trees older than the last 170 years found within the height of twice bankfull depth, even where the banks were stable. This was verified by our coring of trees and counting growth rings. Figure 90 shows the bed profile (solid blue line) in 1987. Black dots along the blue line are bedrock outcrops within the thalweg. The red dashed line is the projected bed elevation of the 1830s. Note how this surveyed profile differs from the USGS 7.5' quadrangle profile (Figure 19, page 14), which is too general to reveal important local detail.

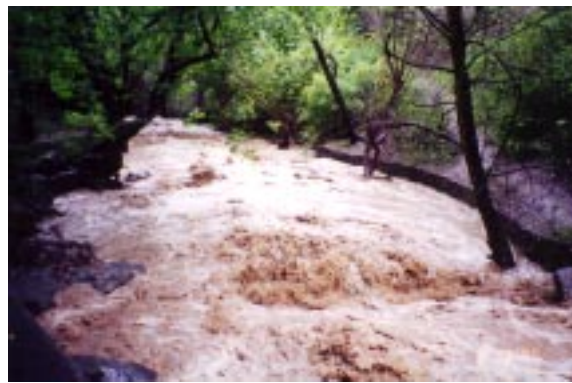
(Photo 61) March 1995 Wildcat Creek near peak flood in Alvarado Park.
