WILDCAT CREEK WATERSHED

A Scientific Study of Physical Processes and Land Use Effects

June 2001

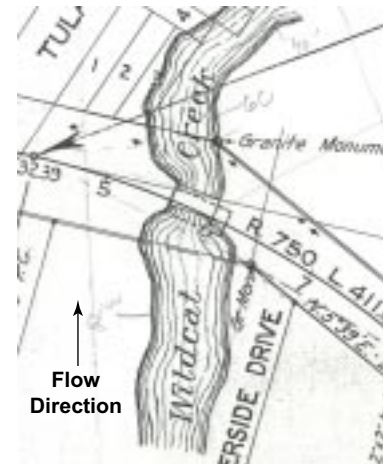
1927 early bridge across Wildcat Creek at San Pablo Road. Note the narrower width at bridge crossing. Source: City of San Pablo.

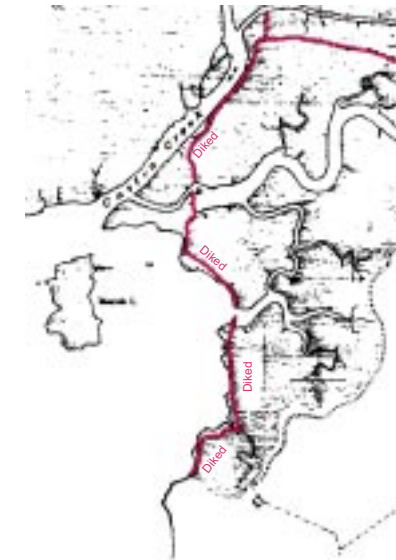
Dikes in southern Wildcat Marsh circa 1860. Source: US Coast Survey T2445 1898.
