**Geomorphic Characterization of Historical Reservoirs,
Stock Ponds and Wetland Landscapes
Supporting Red-legged Frogs
in the
Phillip Burton Wilderness, Point Reyes National Seashore**

FINAL REPORT FOR THE POINT REYES NATIONAL SEASHORE

Laurel Collins and Joshua N. Collins, Ph.D.

March, 2007

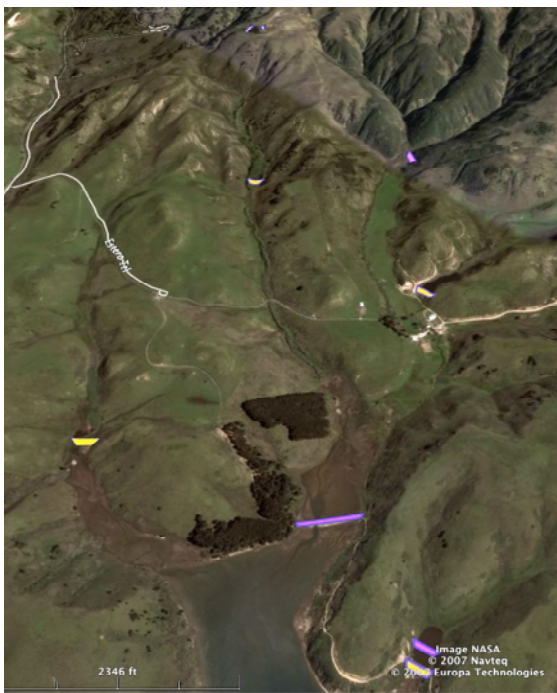
Figure 2: West Home, East Home, and Home Ranch watersheds (left to right) showing mainstem dams. Pink dams are breached.

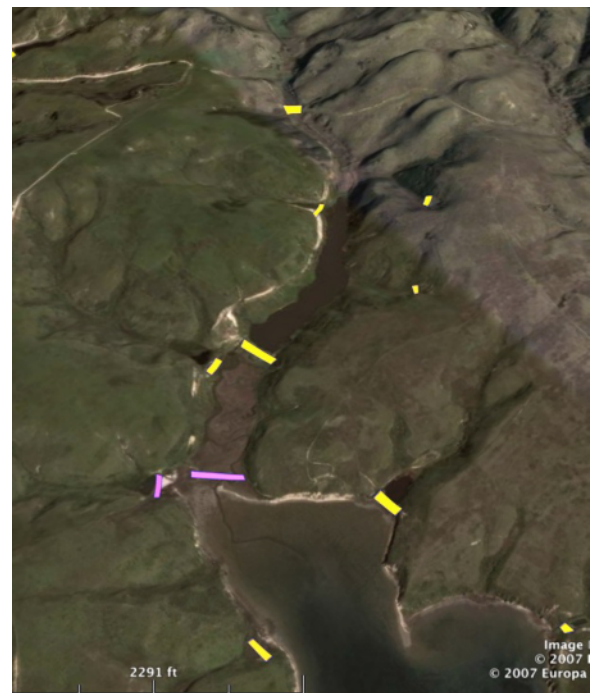
Figure 3: Big and Little Limantour watersheds (left to right) showing mainstem and major tributary dams. Pink dams are breached.

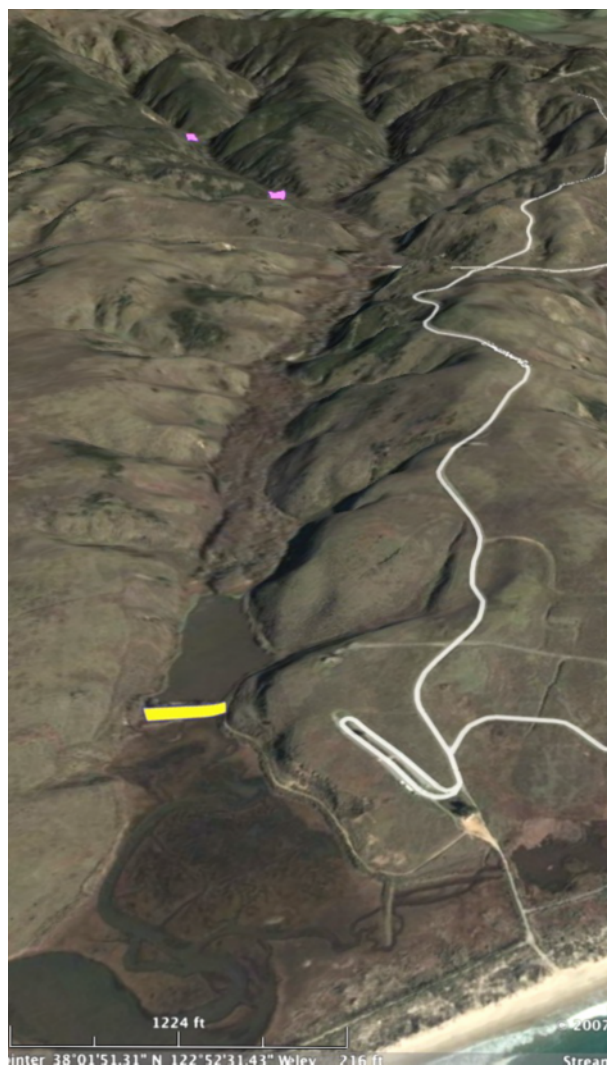
Figure 5: Muddy Hollow watershed showing mainstem dams. Pink dams are breached.

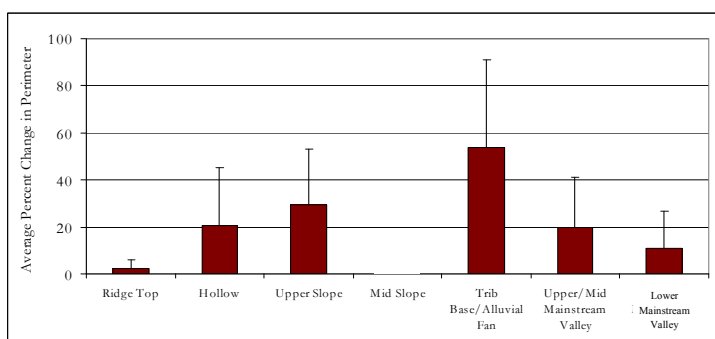
Figure 9: Relationship between the geomorphic setting of a site and its tendency to fill-in with sediment from upstream sources, as indicated by its maximum percent decrease in size as measured in aerial imagery. Breached sites were excluded from this analysis.

Tributary Bases and Alluvial Fans tend to receive large amounts of bedload from the steep Mid Slope areas, where landslides are common. Since the channel downstream of a dam is deprived of sediment (i.e., the sediment needed to maintain the channel's hydraulic geometry is trapped behind the dam), the channel tends to incise. Much of the sediment from the incised channel tends to be deposited in the next downstream impoundment.

The impoundments in the Tributary Base and Alluvial Fan settings are not especially large, however (see Figure 10 below). When impoundment size and upstream sediment sources are considered together, the impoundments at the Tributary Base and Alluvial Fan settings seem most likely to experience in-filling, even if the impoundments above them do not fail. As expected, the impoundments constructed on fans or at tributary confluences tend to be more in-filled than impoundments in any other settings (Figure 9).

The sites that occur in the valley settings (i.e., Upper Valley sites and Valley Bottom sites) receive enough sediment to create forested deltas, but the amount of in-filling is small compared to the large size of these impoundments. A few sites at Valley Bottom settings, such as PC-13, which is a floodplain site below a breached dam, have large modified drainage areas due to their downstream locations (i.e., they are far-removed from upstream impoundments that function as sediment traps. These impoundments therefore have high potential for in-filling (Figure 9).

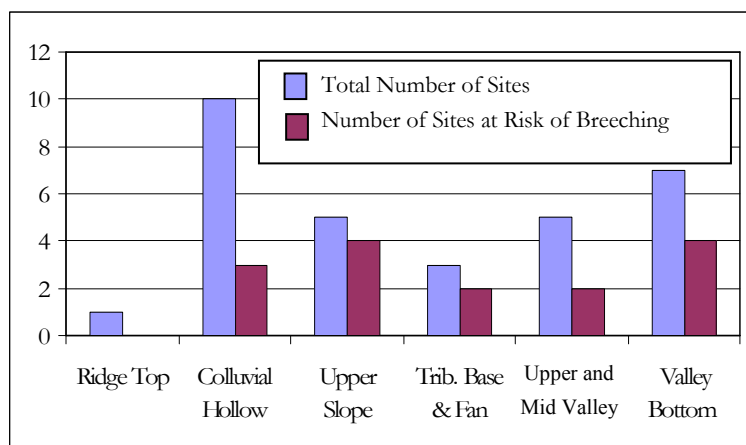
The sites with CRLF represent the full range of geomorphic settings and site sustainability (see Table 4 on next page). Ten of these sites are likely to become at least partially breached in the foreseeable future, and another five sites are already partially breached. Half of the sites with CRLF are at risk of partial or complete breaching (Figure 15).

Figure 15: Sites of CRLF detection in relation to geomorphic setting and site sustainability. Sites that are partially breached or that are likely to become breached are pooled together as sites at risk (see Table 4). Sites not at risk include stable sites and sites already fully breached.

Whether or not such breaching eliminates CRLF breeding habitat depends in part on the residual impoundment left behind the dams after they are breached. Sites that are excavated below the base elevations of their dams might retain enough water to support CRLF breeding. For example, site P-061 has been breached (see Figure 14) but at least one adult CRLF has been observed in the residual impoundment during the breeding season (see Table 4). The current study was not a survey for CRLF.
